# **Inverter-Based Resource Disturbances in the Western Interconnection**

CAISO, NERC, and WECC Staff Report

October 2025

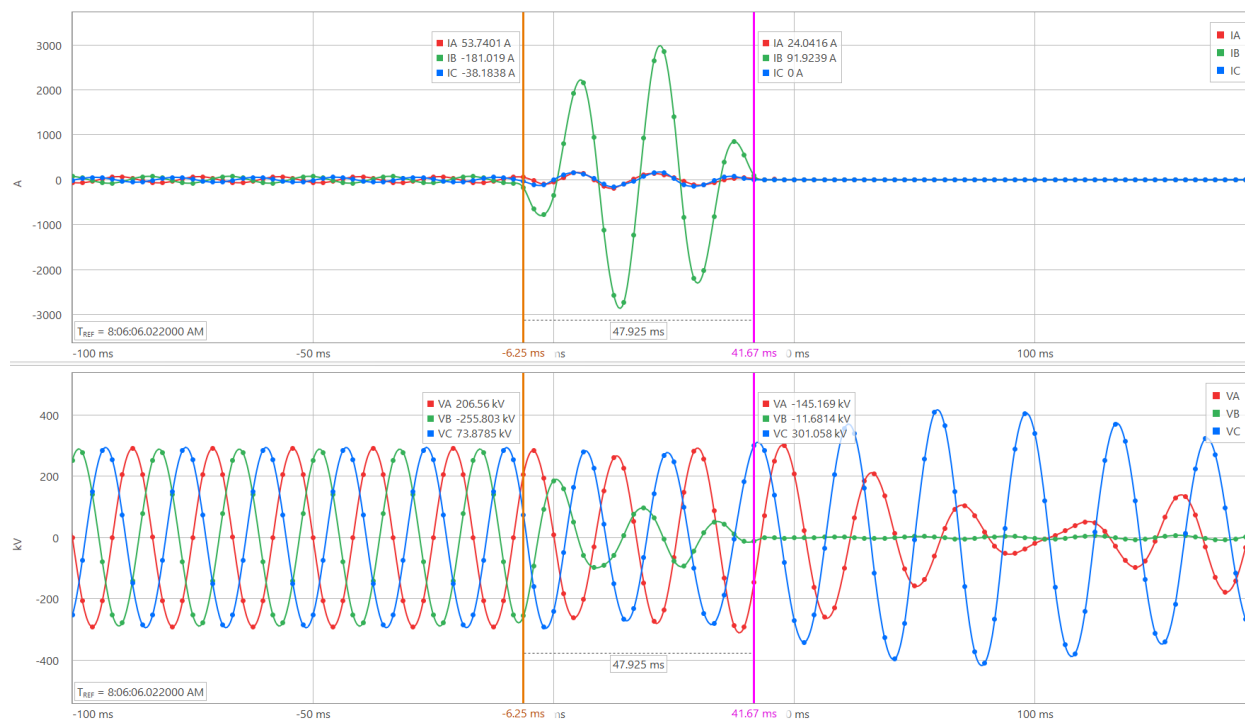
Figure 4: Fault clearing for May 12 disturbance.

**May 12, 2024 “Red Butte Disturbance”:** At 07:06 the Hickory-Red Butte 345kV line relayed out on a phase-to-phase fault. PACE observed a 532 MW reduction in solar PV resources across the area. PACE identified eight solar PV facilities that reduced output due to the fault.

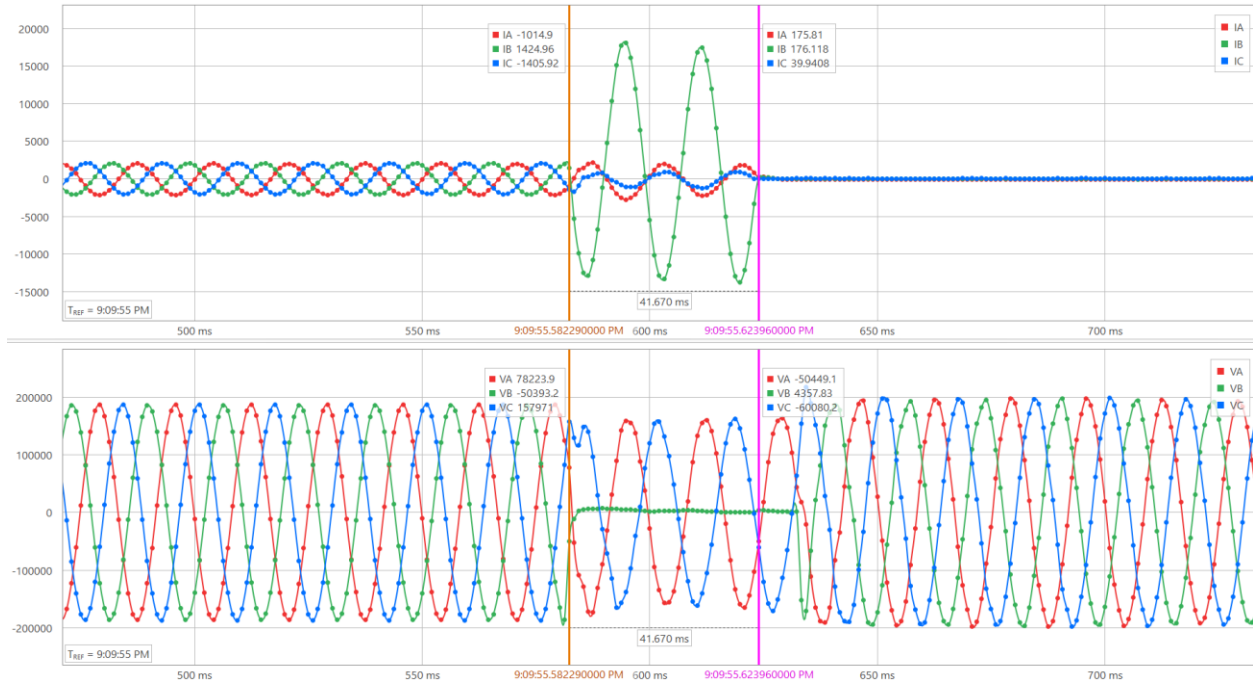
Figure 5: Fault clearing for May 20 disturbance.

**May 20, 2024 “Windhub Disturbance”:** At 21:10:04, the Windhub 500/230 kV 3AA transformer bank tripped on differential protection when a riser lead became separated. CAISO observed a 698 MW reduction in solar PV, wind, and BESS resources. Due to the event time, the majority loss was wind and BESS for this incident. CAISO identified 22 facilities that reduced output due to the fault.

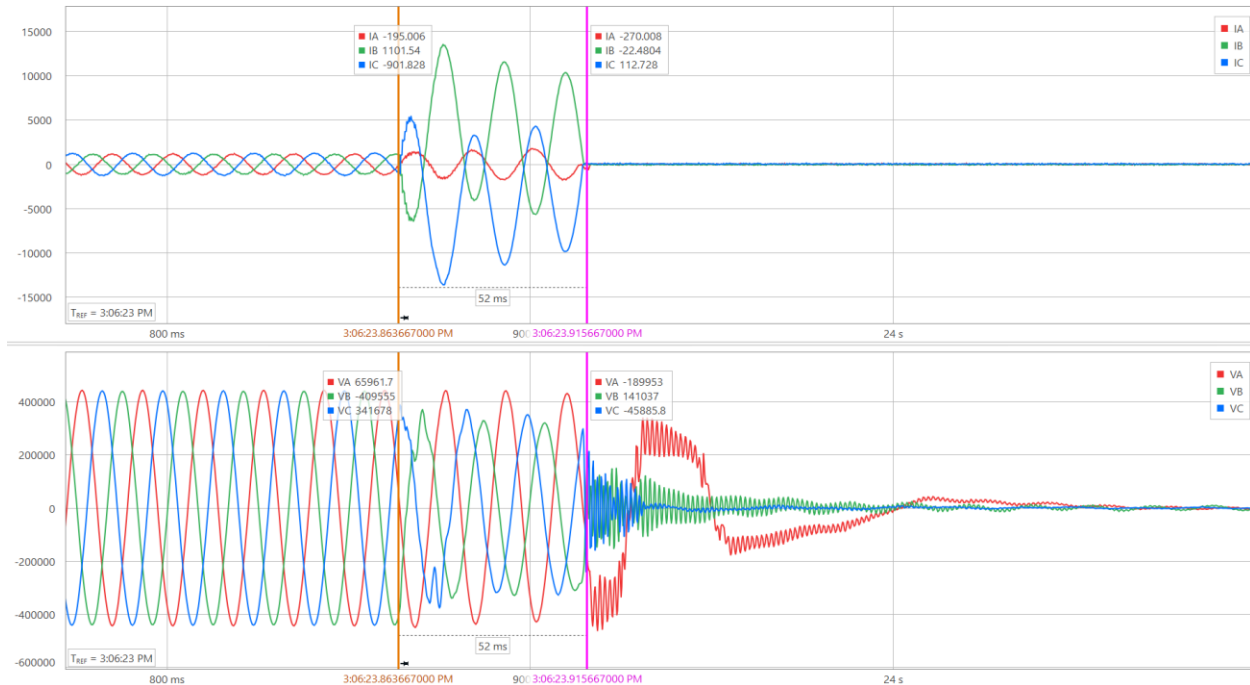
Figure 6: Fault clearing for June 15 disturbance

**June 15, 2024 “Post Fire Disturbance”:** At 15:06:40, the Post fire burning near the Midway-Vincent corridor resulted in the trip of the Midway-Vincent #1 500kV line. CAISO observed a 934 MW reduction in solar PV, wind, and BESS resources. At 15:07, the Midway-Vincent #2 500kV line also tripped. The lines remained out of service until the fire burned clear of the corridor. CAISO identified 37 facilities that reduced output due to the fault.
