# The Jersey Tornado

1 November 2023

## Site investigation report by the Tornado and Storm Research Organisation (TORRO)

SI20231101\_Jersey

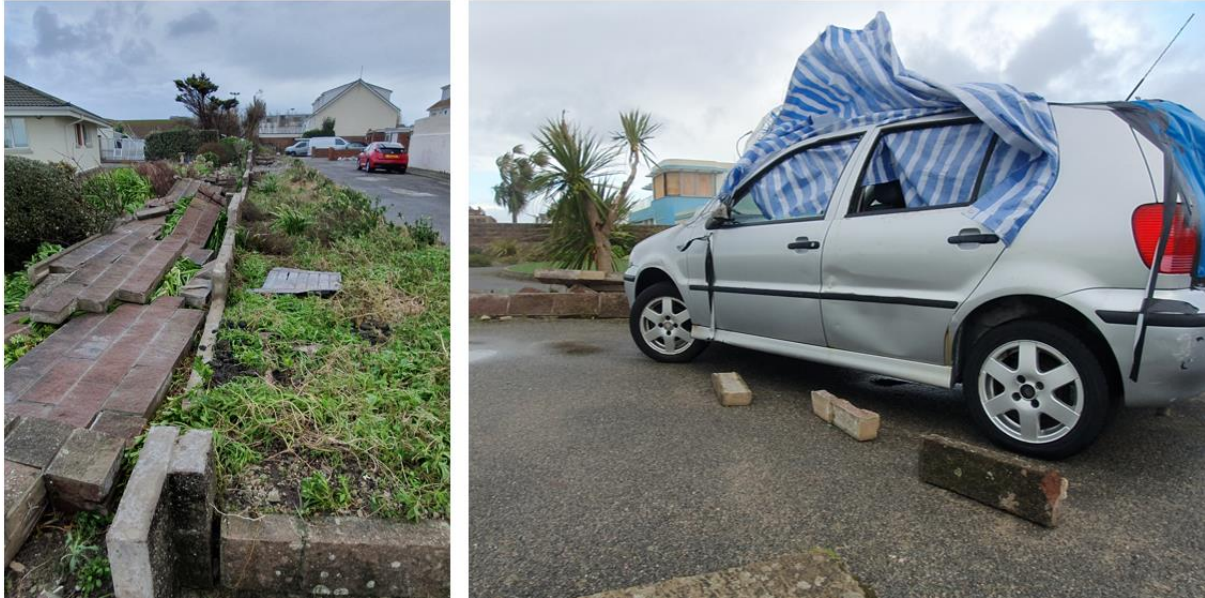
To the west of this point, at (49.1708N, -2.0854W) a house was spotted with general roof damage on its south-east facing side and was categorised as **T2** damage intensity. Nearby, to the north-west a single layer garden wall had collapsed to the south and north. A car parked close by had multiple windows smashed and dents in the rear nearside door. It was determined that the blocks next to the car were probably intended to hold down a protective tarp rather than having travelled from the wall a few metres away (Figure 5).

*Figure 5: Collapsed garden wall and a damaged car parked by it.*

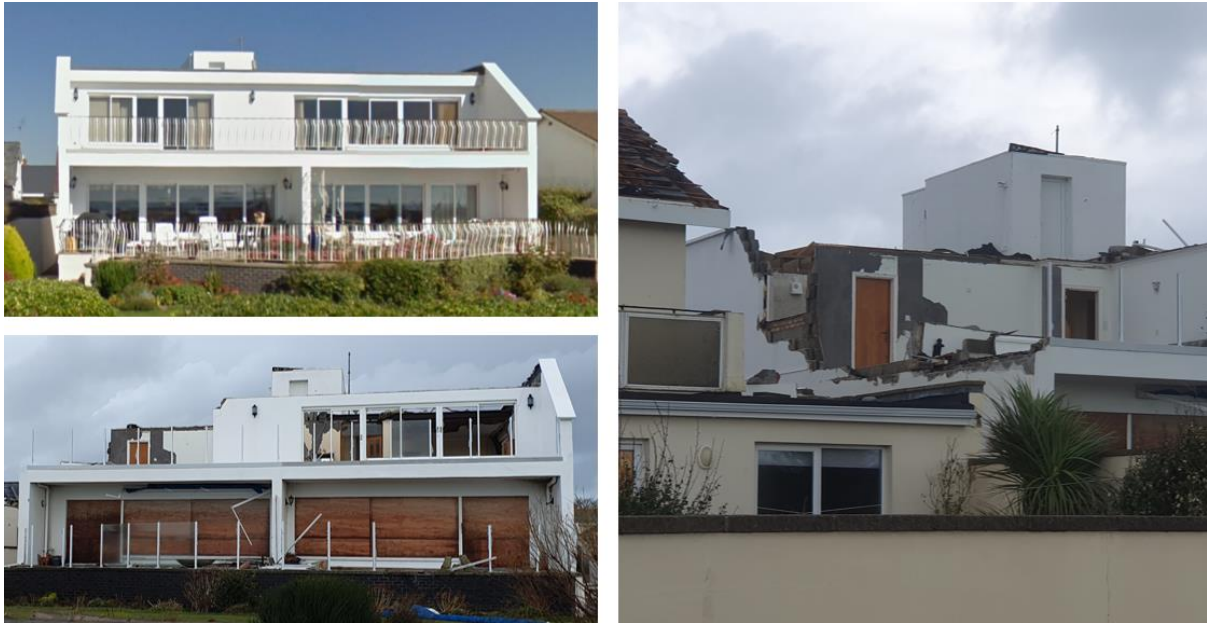
A two-storey brick built residential home (49.1717N, -2.0869W) suffered severe damage to the north-western end of the upper floor. Collapsed walls revealed the interior of the building. The walls fell to the north-west. The roof also appeared to be missing (Figure 6). This damage was rated as **T5**.

Figure 6: Beach front property in St Clement, before and after. This lost a substantial part of the upper floor as well as the roof. All beachside windows were smashed.

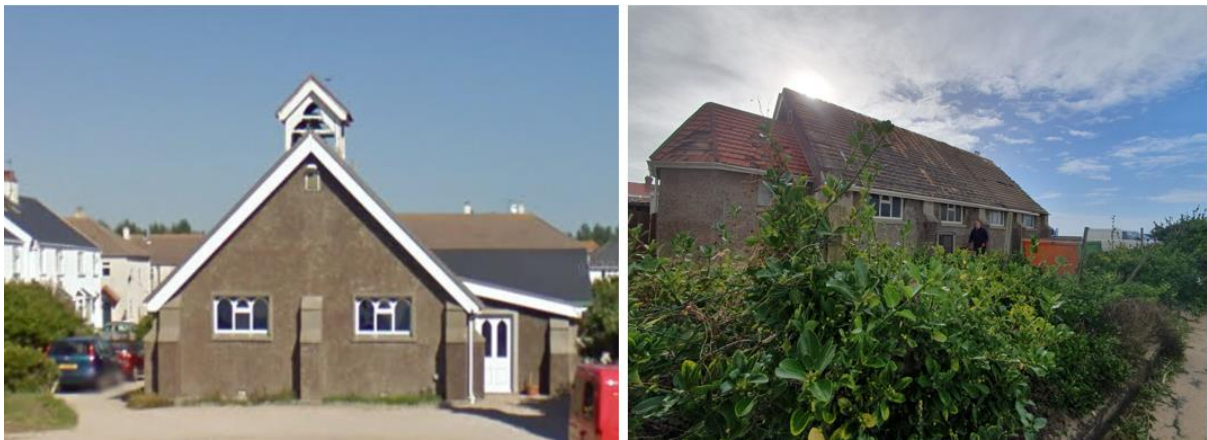
100m to the north-west of this location, Tiles had been stripped from both sides of the roof of St Nicholas Church (49.1725N, -2.0876W). People who were clearing up at the church at the time of the investigation felt that the roof structure had been lifted and replaced by the tornado. The bell tower and front fascia of the building were missing (Figure 7).

Figure 7: St Nicholas Church, St Clement. Before (looking from the south) and after (looking from the west).

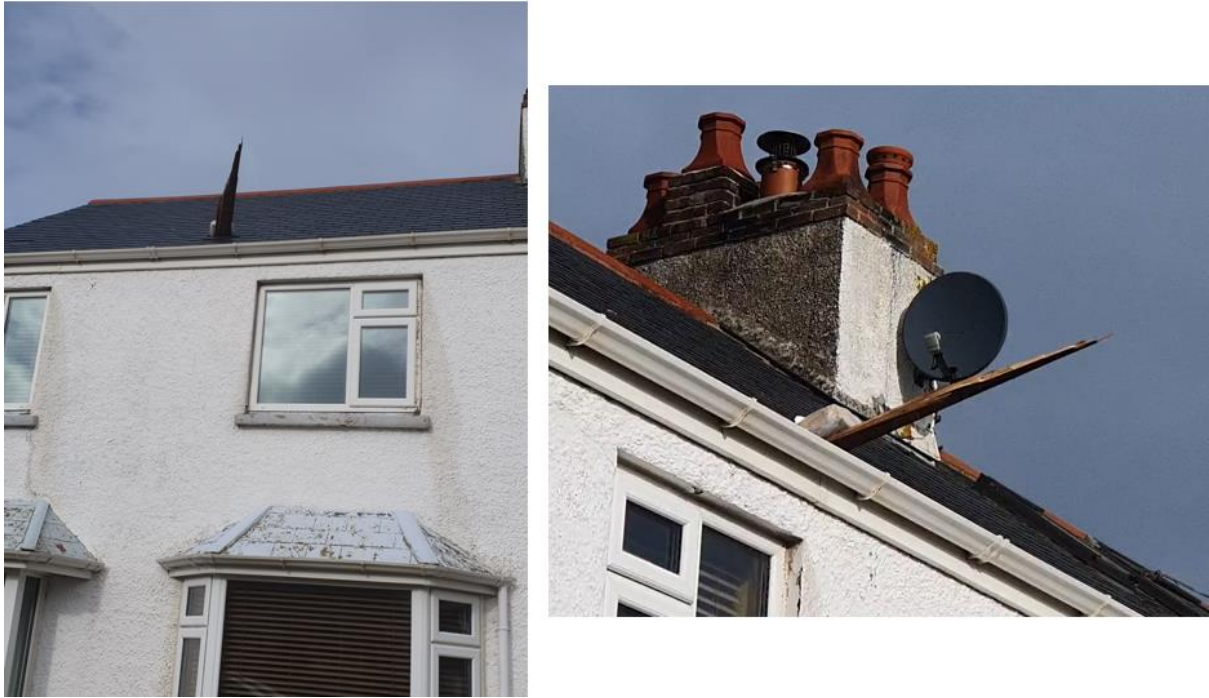
15m to the north-west of the church, a home, which appeared to be in good condition, had an intact south-west facing roof apart from a beam of wood projecting out of the south-eastern side of the roof. It is uncertain where this debris came from, but there was speculation from people working at the church that it may have come from the church (Figure 8).

Figure 8: Two views of a property close to the sea front which appeared intact other than debris projecting from the south-eastern side of the roof.

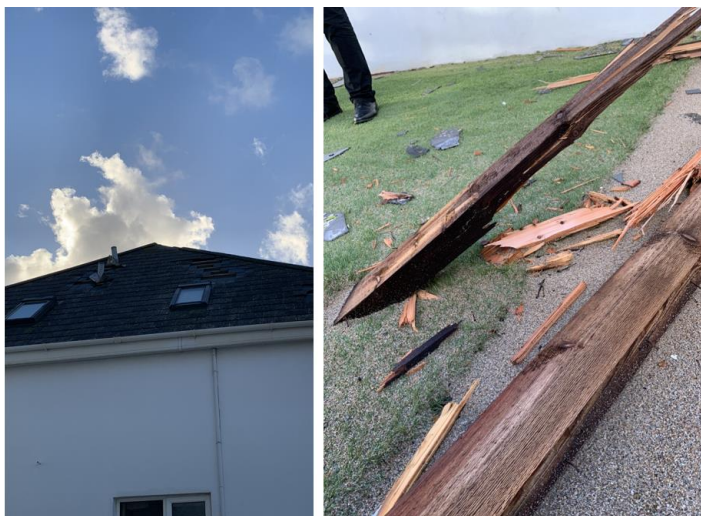
Continuing westwards along the coast road there was relatively little damage for around 100m. **T1** roof damage was evident from the footpath with slightly more intense damage around the most westerly point of damage (the junction of Plat Doet Road and La Grand Route de la Côte (49.1738N, -2.0880W).) A window in a garage was said by a resident to have blown outwards. Pieces of guttering were found by the aforementioned resident to be embedded between windows and window frames. A piece of wood, thought to be a joist, flew through the air and smashed tiles and a sun lounger before becoming embedded in an artificial lawn (Figure 9). Residents did not know where this joist had come from. Car and house windows were described as being ‘sandblasted’ and will need replacing.

Figure 9: Damaged roof (left) and embedded roof timber in artificial lawn (right). Credit Angela Little.

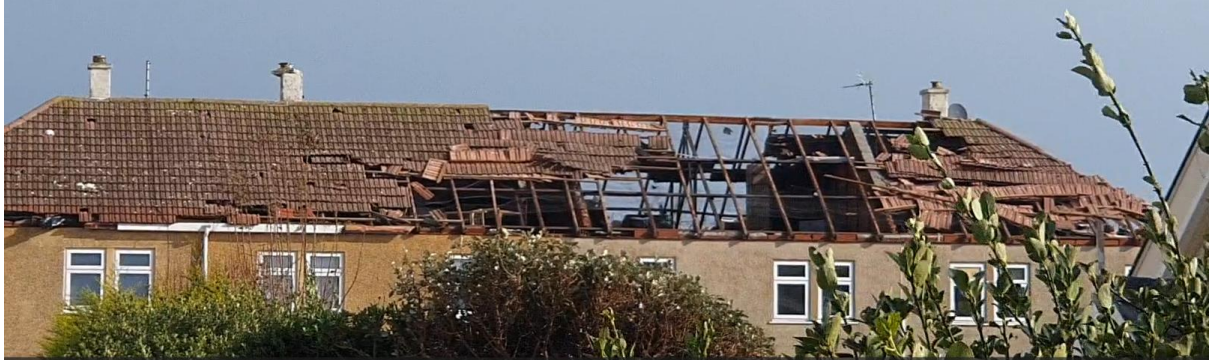
Behind St Nicholas Church lies an area known as the Florence Boot Cottages. Numerous houses at this location suffered damage consistent with between **T2-T4** strength. Some homes within a terrace, directly behind St Nicholas Church (49.1728N, -2.0869W), had their roof timbers exposed (Figure 10). Homes showed considerable damage to the render from debris. Some chimneys which fell were noted to have fallen from east to west.

*Figure 10: Homes behind St Nicholas with exposed roof joists.*

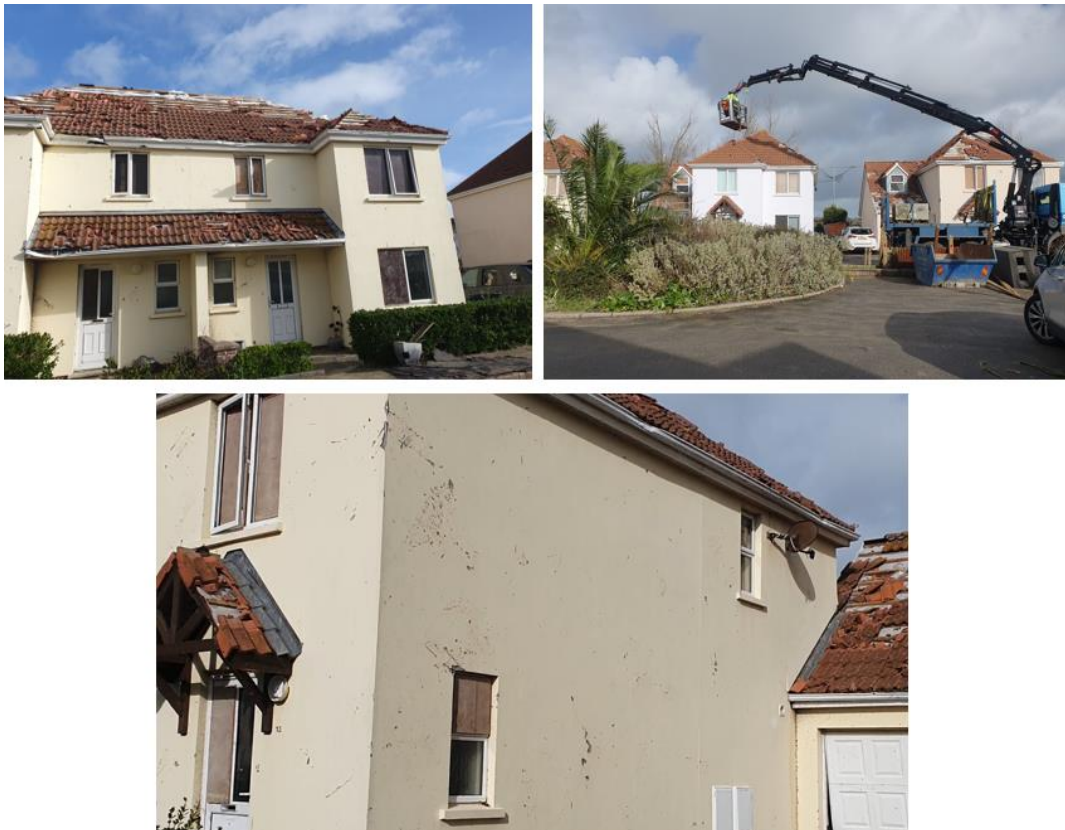
*Figure 11: Typical damage to many homes in Florence Boot Cottages. Roof damage and deep gouges to the render.*

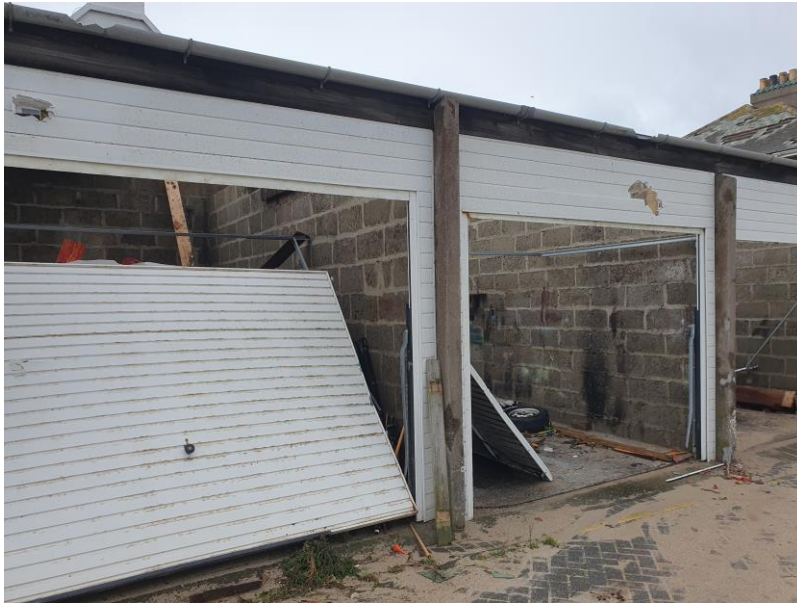
A block of garages lost their roofs. Rafters were missing and there was no sign of the majority of them (49.1723N, -2.0866W). The garage doors on the north-east face of the garage block had blown inwards (Figure 12).

Figure 12: Block of garages with missing roof.

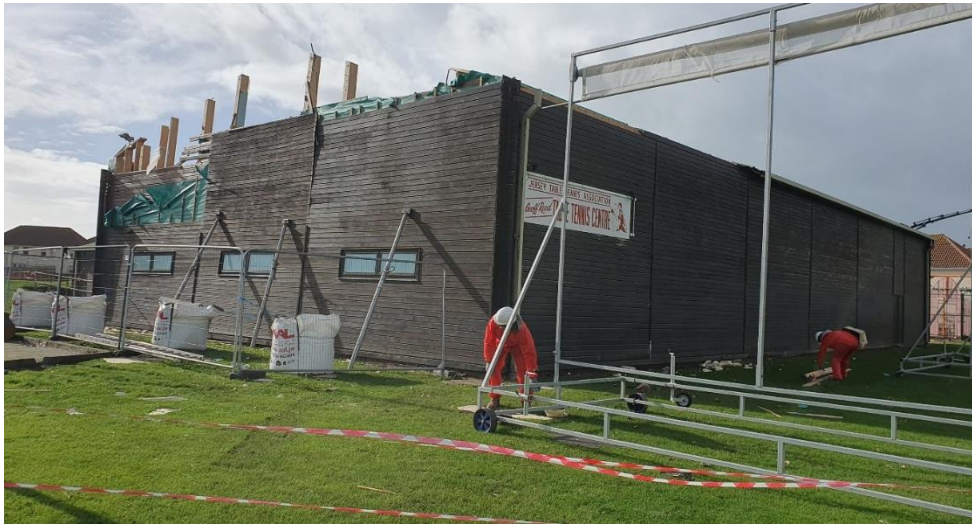
At the south-western end of Florence Boot Playing Fields, the Geoff Reed Table Tennis Centre (JE2 6QN) was badly damaged (Figure 14), especially across the south-western end where approximately 1/3 of the sheet metal roof was lost. Drone footage shows the damaged front wall fell forward.

Figure 14: Geoff Reed Table Tennis Centre looking at the south-western face of the building.

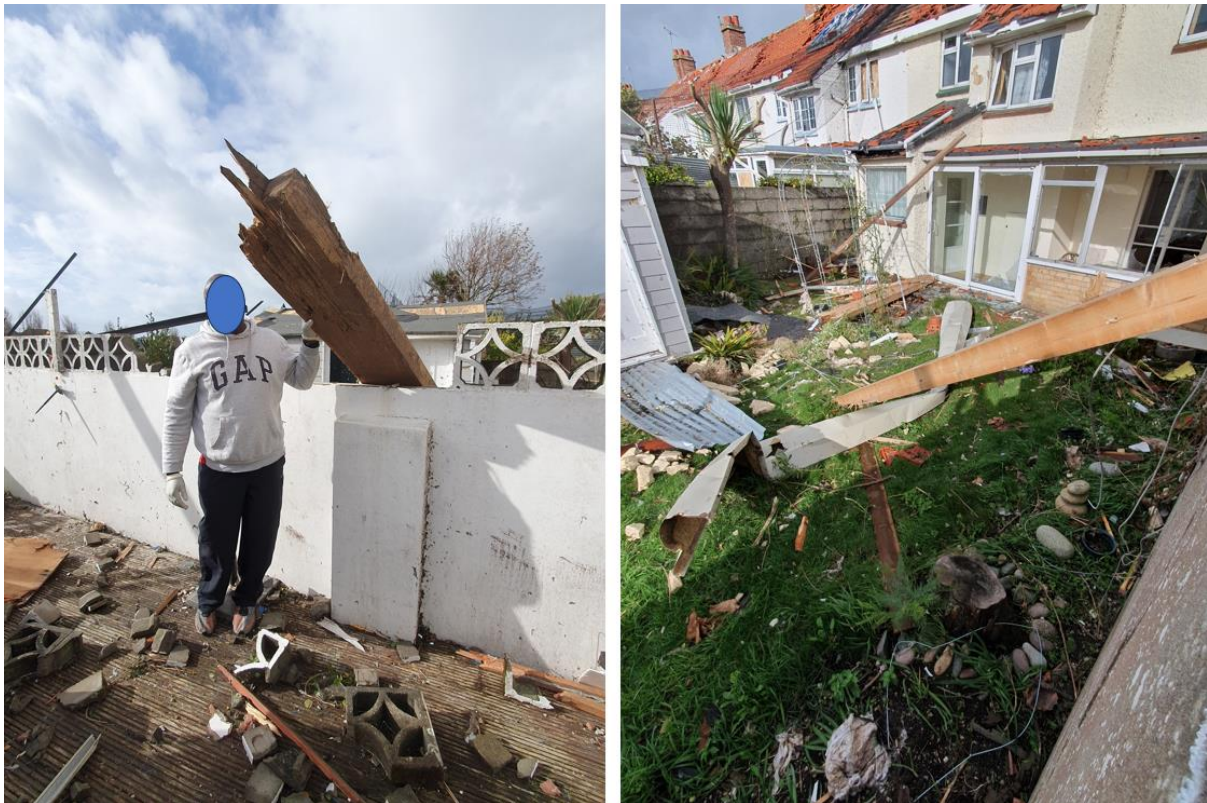
Wooden beams (dimensions over 5m long with a cross section of 0.3x0.12m) were lost from the building and were carried 150m across the playing fields to land on the fields, and in at least one case, over a wall into a garden. The beams were estimated to weigh around 100kg (Figure 15). The throw of these beams was assigned a rating of **T6**.

Figure 15: Large beam of wood from the Geoff Reed Table Tennis Centre thrown 150m north-west.

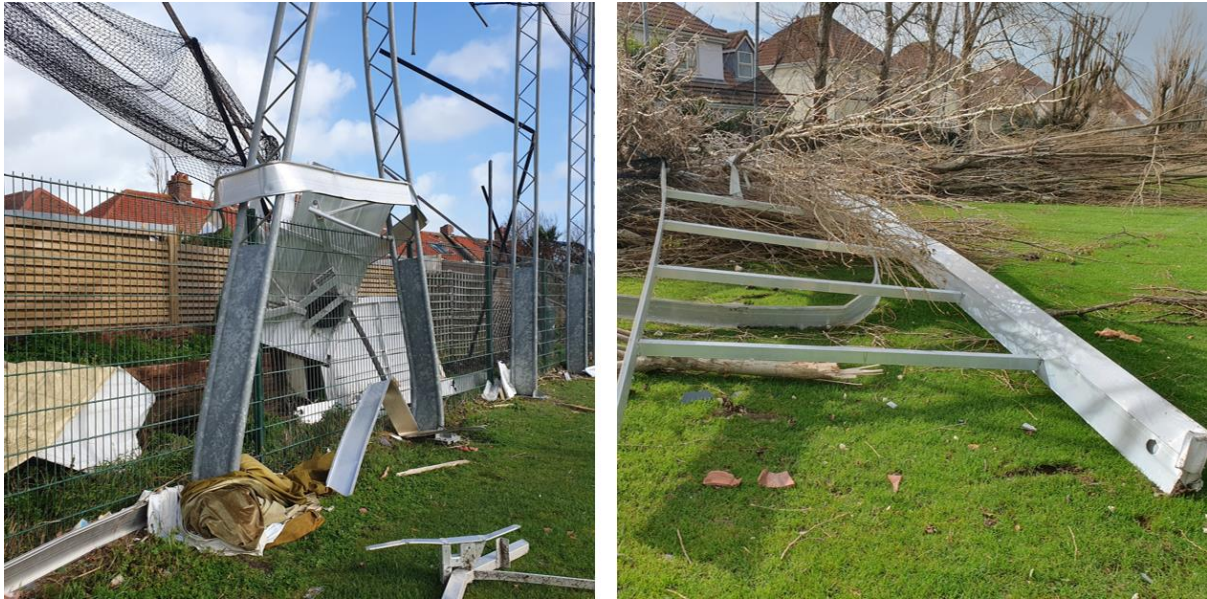
Spread across the field was a 200m wide swath of debris. Intense damage to trees and the southern and northern boundary fences occurred for 100m across both sides of the field, indicating the strongest core area of wind in this part of the track. The metal fence posts were bent north-eastwards in places and metal structures were torn and twisted, indicating **T4** damage. In the carpark to the north of Florence Boot Playing Fields, a large metal clothes recycling bank rolled onto a car before landing on the road approximately 40m from where it started. A lamp post, apparently hit by debris, folded to the road. Both of these were assigned **T5**.

*Figure 16: Metal structures torn and twisted at the southern side of Florence Boot Playing Fields.*

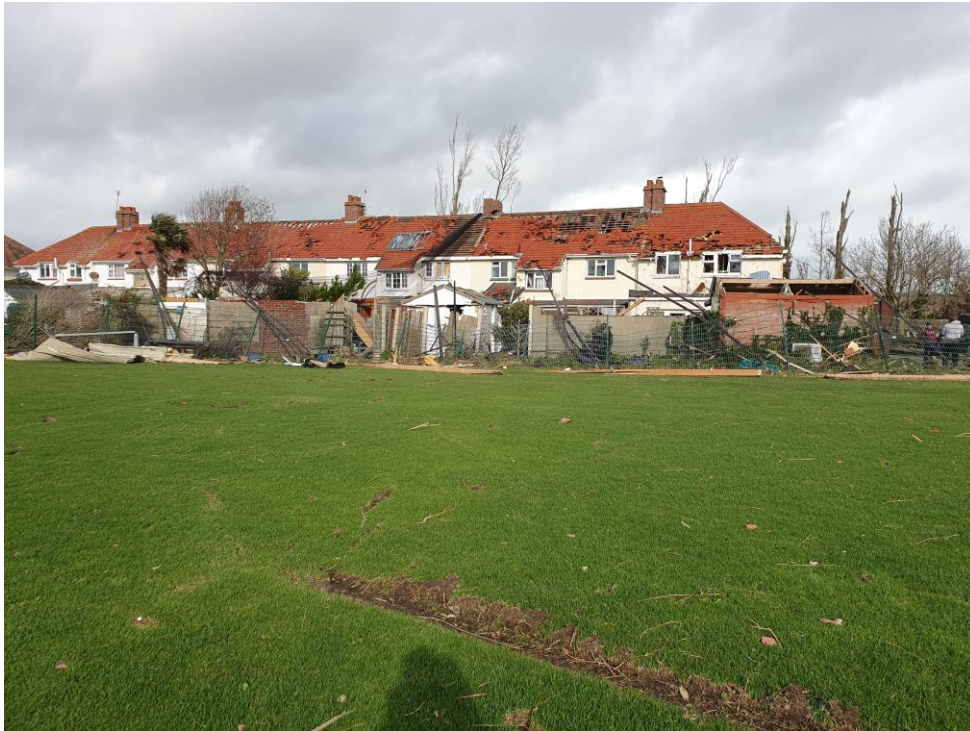
At the same home where the large wooden beam landed (49.1745N, -2.0847W), there was **T3** roof damage. A resident of these cottages (pictured in Figure 15) was clearing up damage and was happy to show some of the damage that occurred. He described lying in his low-profile bed, when suddenly the window shattered, and debris flew just above him. He said that “Tiles and stuff like that shot like a cannon across the room.” His internal bedroom wall blew down. He said that he left the room rapidly and sheltered downstairs.

Figure 17: Houses on the northern boundary of Florence Boot Playing Fields where the internal bedroom wall blew down. The boundary fence can be seen to be badly damaged.

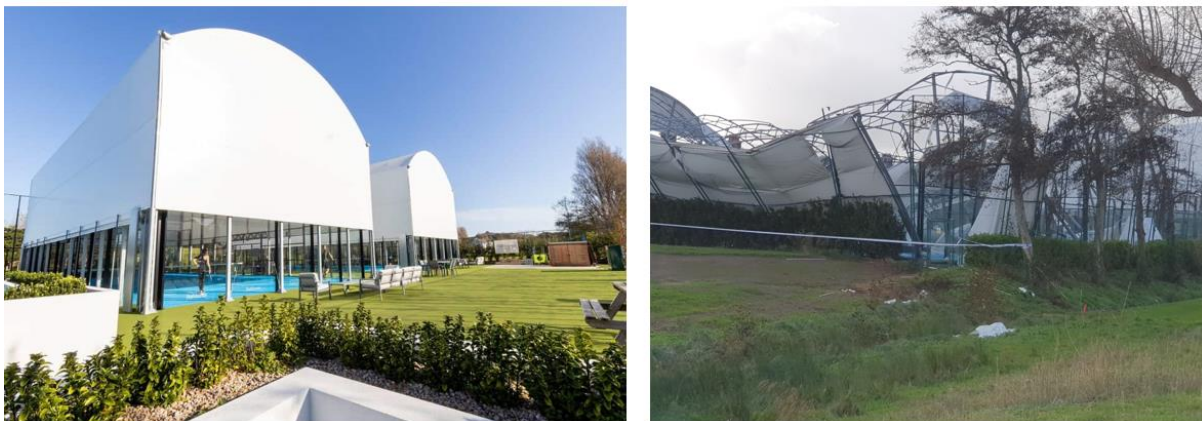
70m to the north-west of these houses (49.175N, -2.0856W) a sports complex known as 'Island Padel' suffered severe damage to the canopy metal structures (Figure 18).

Figure 18: Island Padel sports pavilion was badly damaged. (Before image included for comparison).

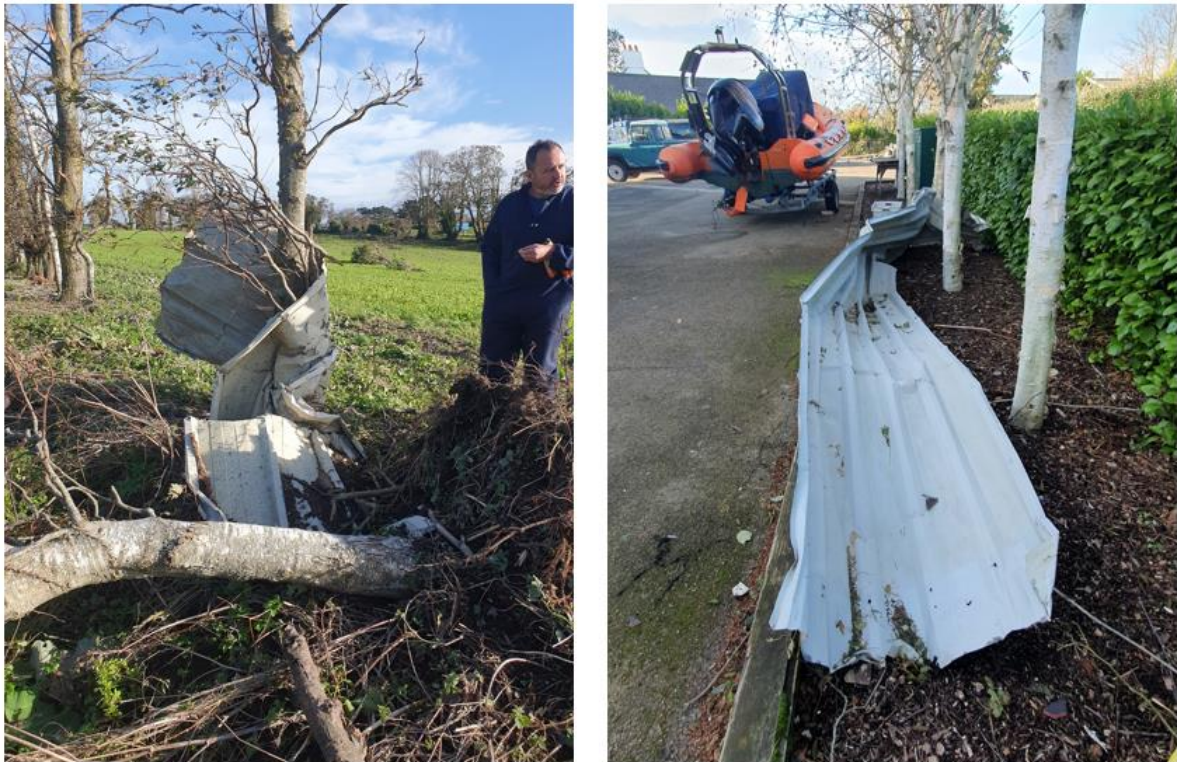
The south-eastern corner of the Rue Des Pres Trading Estate (JE2 7QR) was hit by the tornado. There was substantial damage to warehouses and other buildings. One warehouse (49.1802N, -2.0776W) lost almost half of the metal sheeting from the roof. Metal sheeting from this warehouse and others was found in various locations along the track, wrapped around trees and in hedges up to 1.4km away (Figure 20).

Figure 20: Metal sheeting from the Rue Des Pres Trading estate 1.4km away.

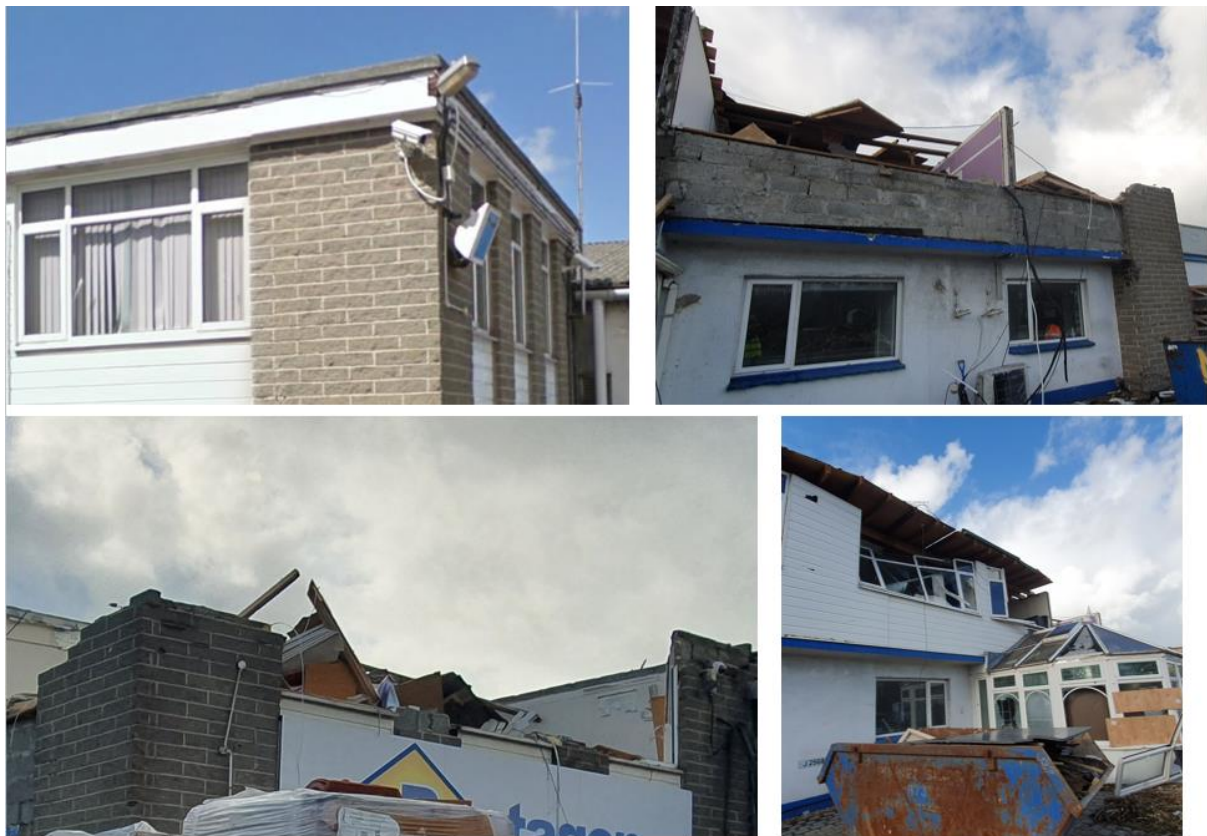
The building belonging to *Pentagon Wholesale* on the trading estate suffered damage to the upper floor (49.1806N, -2.0771W; Figure 21). Part of the eastern upper wall caved inwards and some of the wall was missing. This collapsed wall appeared to be made of clad blockwork. On the north-eastern corner the brick and block pillar partially collapsed with around ten courses of bricks missing. Brick and blockwork pillars which had supported the windows on the northern wall were missing. This was rated as **T5**.

Figure 21: *Pentagon Wholesale* building, before (top left) and after (remaining photos).

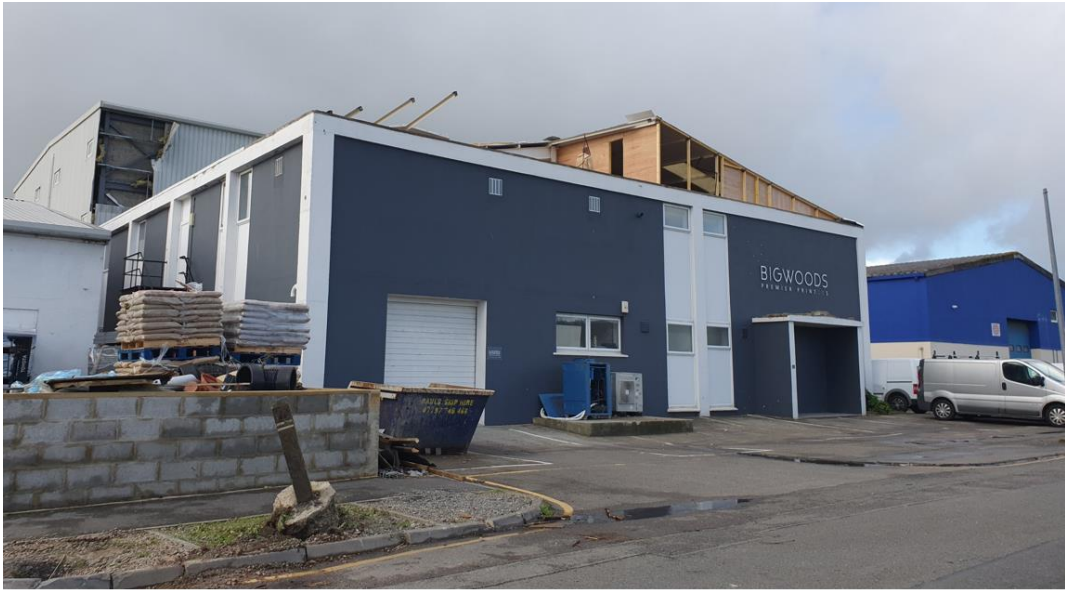
Figure 22: Partial roof loss from another warehouse in Rue Des Trading Estate.

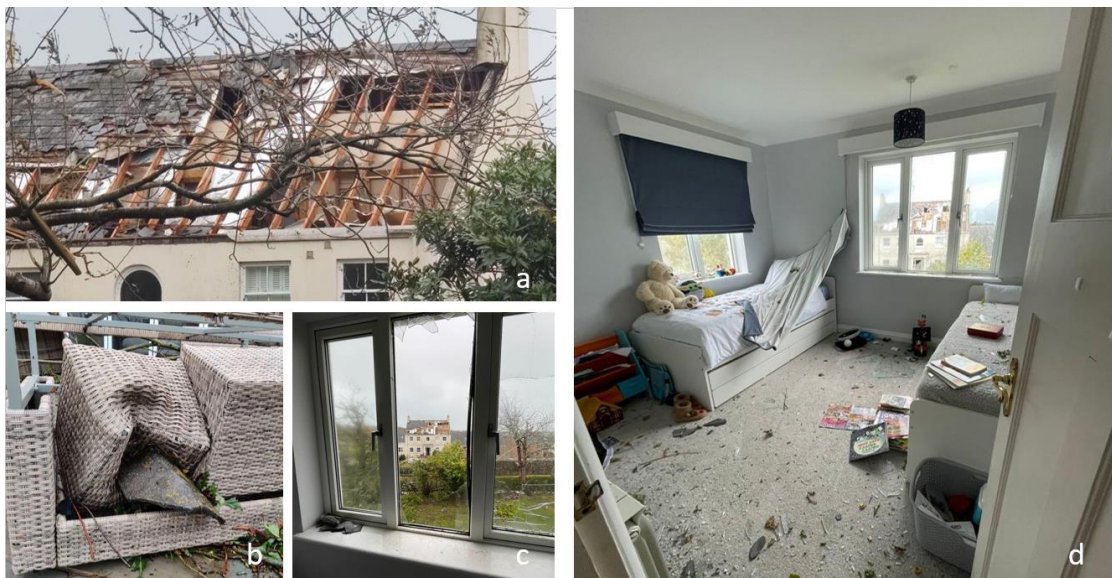
To the north-east of the estate a cluster of homes had been damaged. One property (49.1824N, -2.0741W) suffered some tile loss to the southern face of the roof, but there was much more extensive tile loss to the northern face of the roof. Around 50% of the timbers were exposed. This was rated as **T3** damage.

A property (49.1828N, -2.0740W) 45m to the north of this was hit by debris from the aforementioned house (Figure 23). In the garden, a ridge tile pierced garden furniture, buckling the metal frame. Trees had been felled by the tornado. One tree was found 25m from where it was felled. Windows were shattered by fragments of slate roof tiles and ridge tiles from across the road. An upstairs bedroom was showered with debris.

Figure 23: a) Partially stripped roof (49.1824N, -2.0741W). b) Garden furniture impaled by a concrete ridge tile that flew around 45m. c) Window smashed by slates and ridge tile fragments, with a view to the home to the south. d) Childrens bedroom covered in debris.

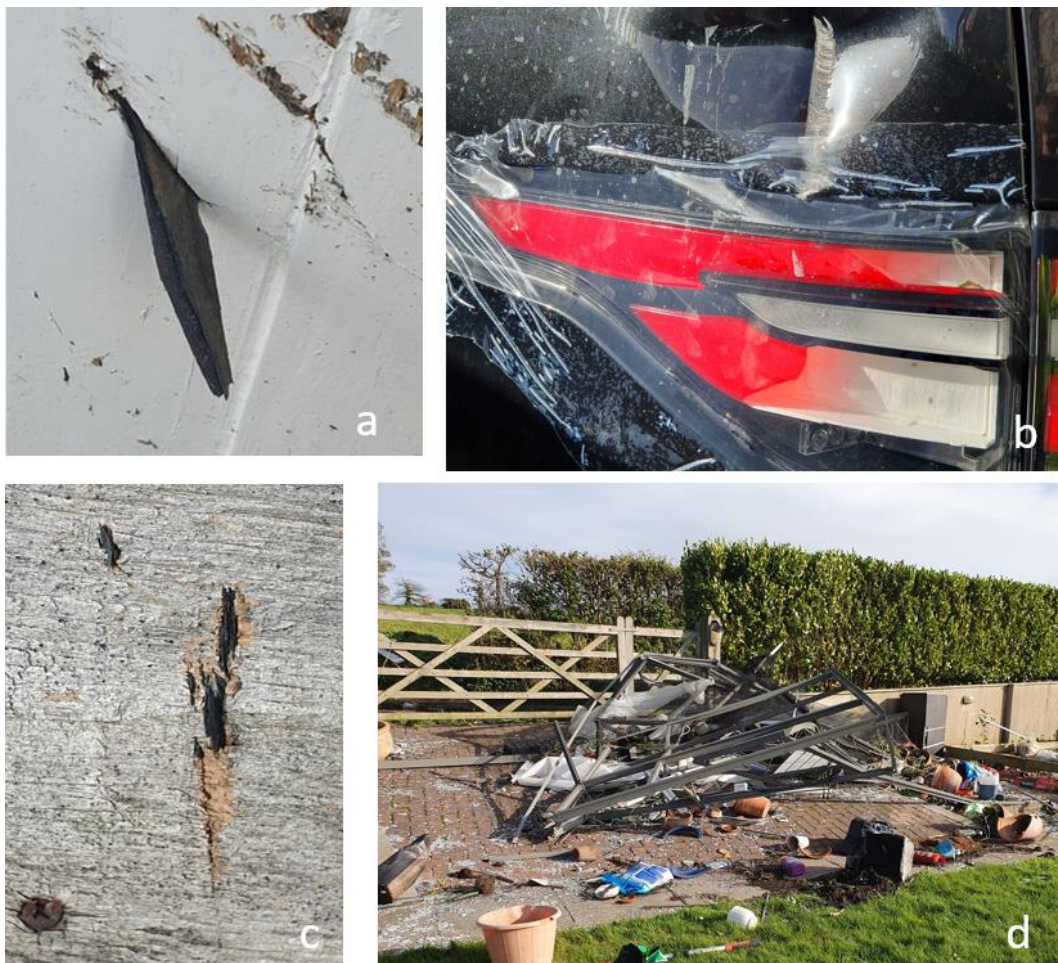
Properties at 49.1871N, -2.0691W, suffered loss of some roof tiles. Debris pierced through garage roofs to cause dents to the cars inside them. There were embedded slate fragments in wooden sleepers to the west of one house, in the soffit on the eastern side of the same house and embedded in the render. A summerhouse in the garden lost its roof and a greenhouse had collapsed. One car was badly dented and scraped by flying debris. The embedded slates fit the criteria for **T6**. However, damage to the properties, other than that caused by flying debris, was estimated to be **T2**. There were many trees felled by the tornado around this area and a road adjacent to the property was impassible due to fallen trees.

Figure 24: a) and c) show embedded fragments of slate roof tiles in render and wooden sleepers. b) Rear wing of a car showing dents and scrapes from a sharp object. d) A collapsed greenhouse.

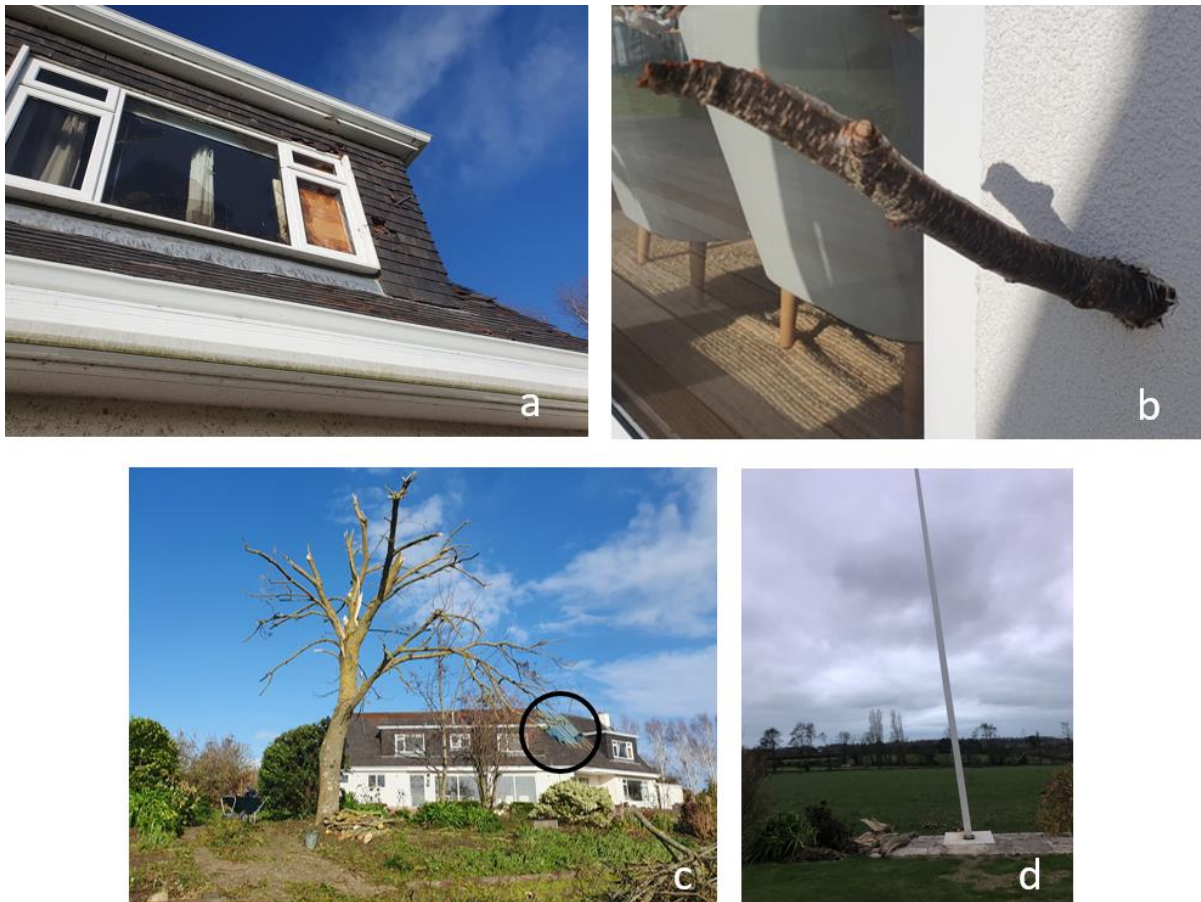
At a property (49.1894N, -2.0677W; Figure 25) the tornado was said, by a resident, to sound like “machine gunfire”. The roof on the south facing section lost many tiles. Debris was found embedded in the render, including a small twig. Debris was also embedded in wall hanging tiles. Damage from this embedded debris was rated as **T6**. A 7m tubular steel flagpole had been bent and had been partially levered off the base plate.

Figure 25: A property in Boulivot. a) Smashed window and embedded debris. b) Twig with estimated diameter 1cm embedded in render. c) View of house showing roof damage. d) Bent Flagpole which had partially been separated from its baseplate, separating partially from the baseplate. (credit Lee Battrick)

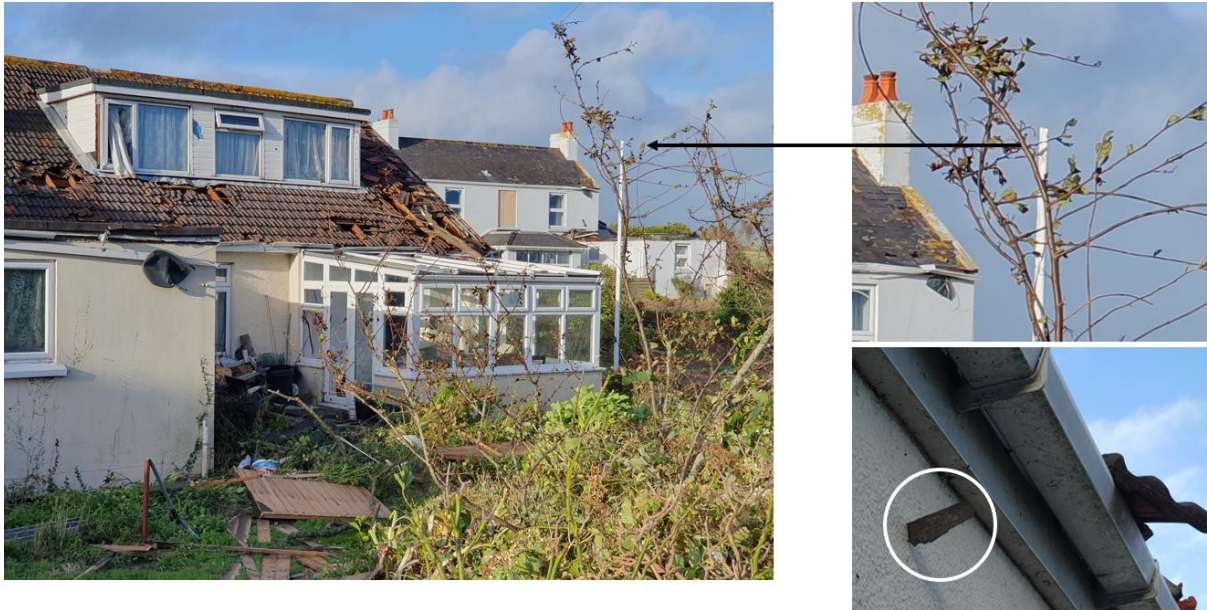
As well as roof damage at their property (49.2010N, -2.0533W), a fragment of a roof tile was found embedded in render. This embedded debris was rated at **T6**. A garden wall had been blown down, as had many trees.

Visible from their home was their neighbour’s property. A large branch was embedded in the roof of that property. The aforementioned resident said that the ceiling in the house came down and the property was now uninhabitable. The gentleman living there was said to have slept through the event. An inspection of the photo reveals what appears to be a flagpole snapped at the top.

Figure 28: Property with embedded branch and a damaged flagpole and an example of embedded roof tile at another property along the La Route de la Hougue Bie.

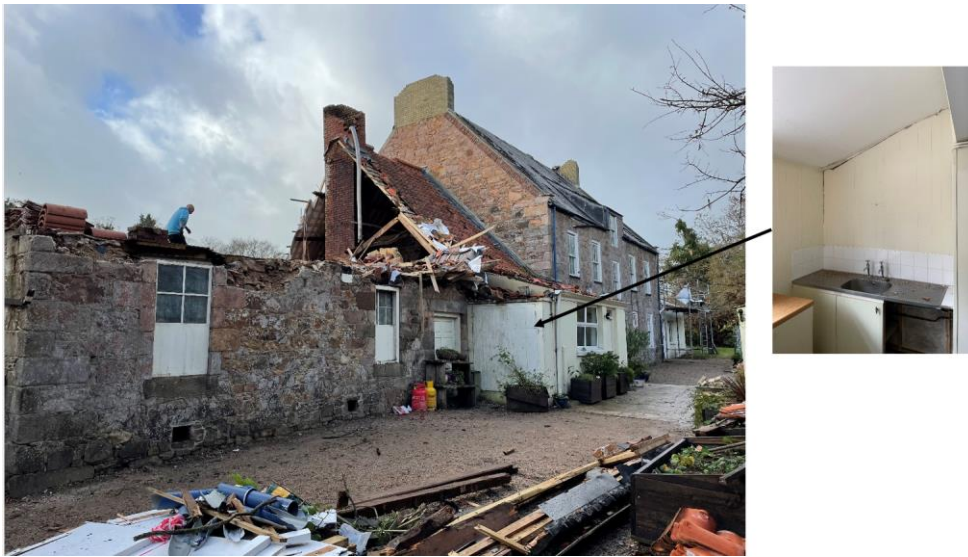
This location was visited by Jersey resident Ian Tillotson on behalf of TORRO on 19 November 2023. All locations refer to those marked in Figure 29. The farmhouse (marked ‘a’ on the map) lost tiles from the unfelted roof and the two chimneys were partially toppled. There was significant roof damage from the toppled chimneys. Some of the windows blew in. Internal doors inside the farmhouse now jam and it was felt that there had been movement to the internal walls. The kitchen lean-to extension appeared to have shifted as there was internal cracking at the ceiling and wall corners. This damage was rated at **T3**. Mr Tillotson spoke to the resident tenants. They described being woken by a lightning storm, quickly

Figure 30: North face of the farmhouse (a) and attached barn (b). The farmhouse suffered tile damage, partially collapsed chimneys and blown out windows. The cream building is the lean-to extension, less well constructed building which appears to have shifted position. Credit Ian Tillotson.

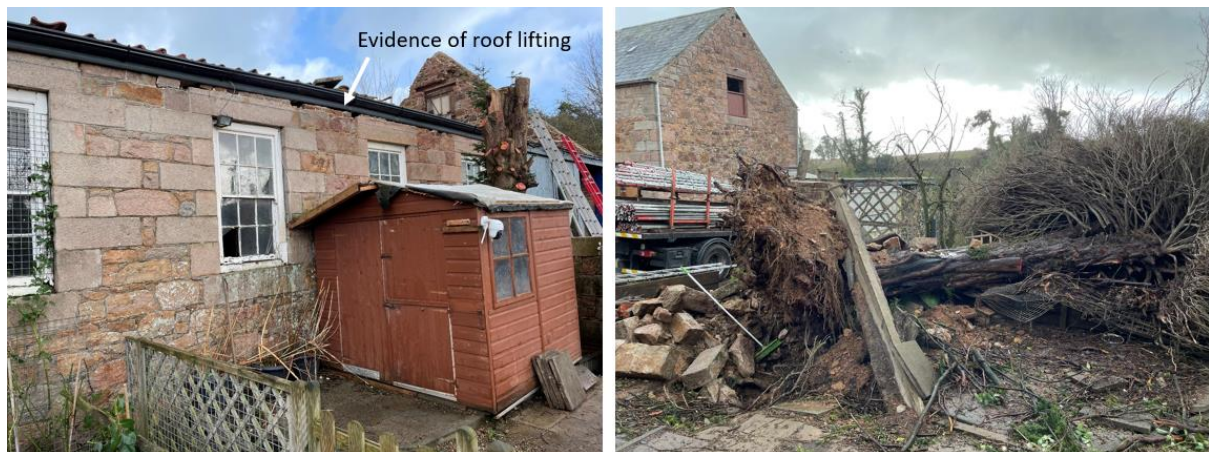
At the front (southern face) of the main farmhouse, there was visible lifting of the guttering and the linked fascia, and it was evident that the roof had been detached in an upwards direction. The large tree at the front of the property had fallen towards the west.

Figure 31: Evidence of the roof having lifted on the southern face of the farmhouse. A tree toppled towards the west.

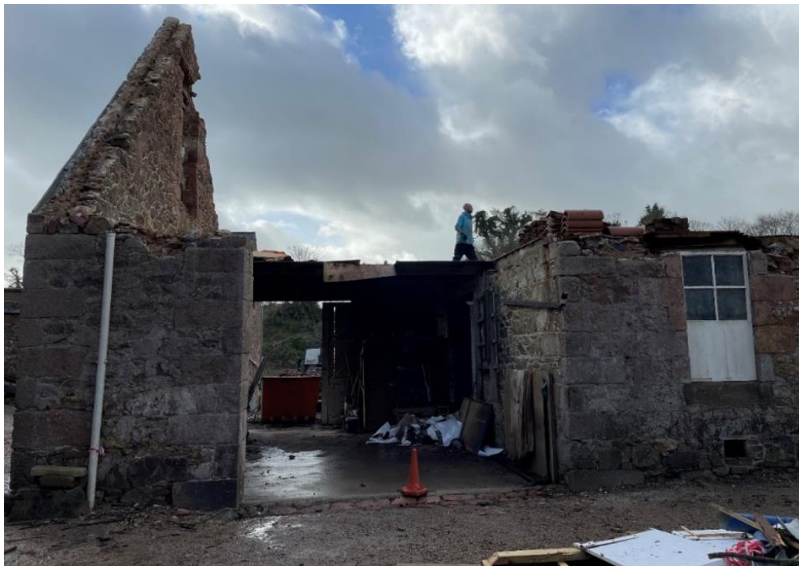
The attached barn (Figure 32 and 39) showed severe damage with almost total loss of the roof. A single skin brick chimney stack had been partially toppled and this landed on the barn roof. Mr Tillotson spoke with the roofing contractors on site. They said that the roof had been replaced approximately 6-7 years ago and at that time they had been instructed to cement down the ridge tiles. The remaining granite wall at the north-eastern corner of the barn had visibly moved and was leaning outwards with cracking visible in the wall. At the top of the gable end that was still standing, there was a missing lintel. It was not clear if this was wood or stone, but there was no sign of the lintel.

The internal stone side wall on the barn was also significantly cracked from where it has been moved. This damage was rated as **T5**.

Figure 32: Attached barn (Figure 35 'b') showing roof loss and damage to remaining walls. View of the eastern end of the northern side. Credit Ian Tillotson.

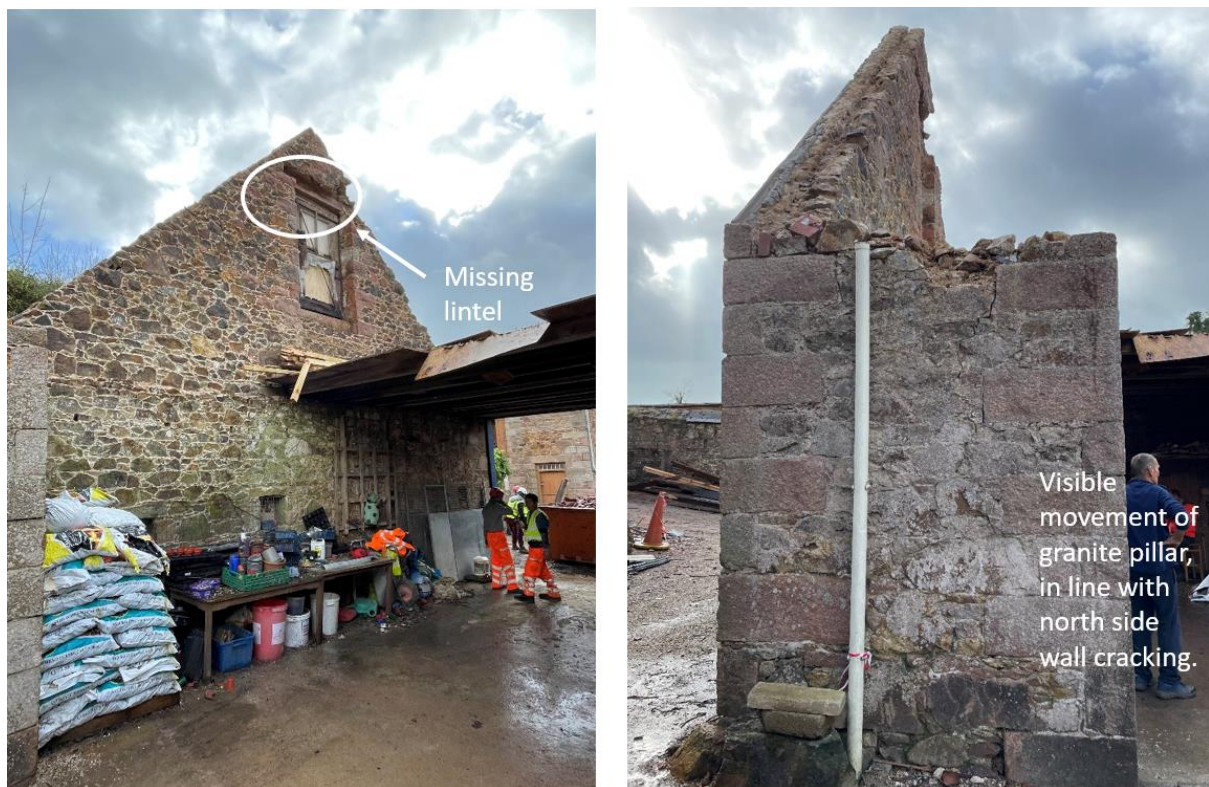
Figure 33: Closer detail of damage to the attached barn.

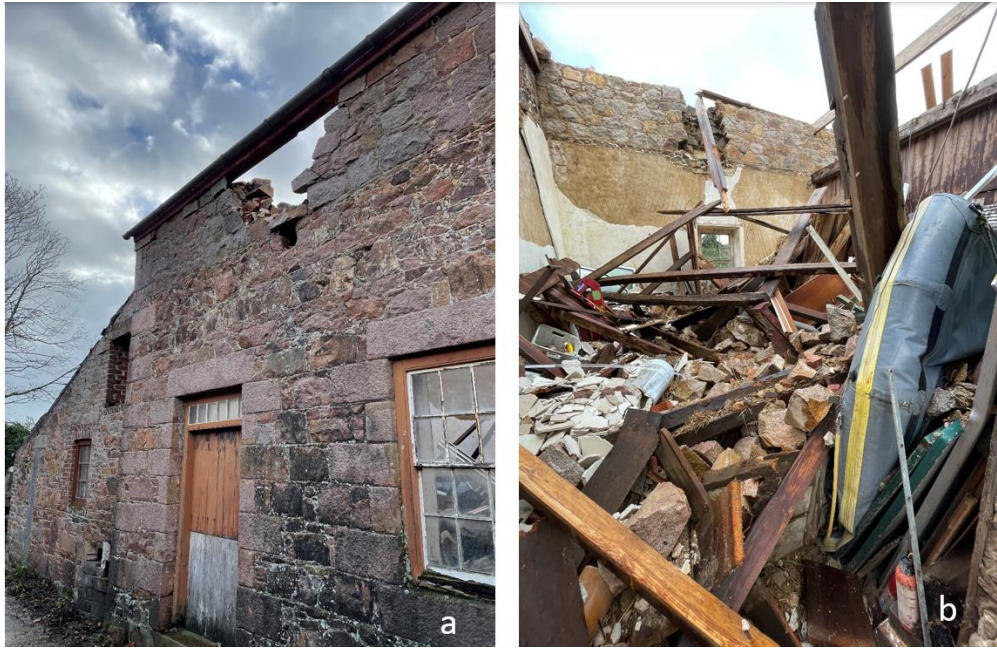
The southern barn (Figure 34) lost much of its roof and the eastern gable end collapsed. There was a large crack evident to a remaining wall at the north-western corner. Towards the eastern end of the north side, an area of the wall above and around one of the windows had been ripped out. The eastern end of this roof had been destroyed including the end gable wall.

Figure 34: a) Damage to the north wall of the southern barn (Figure 29 'c') b) Inside the southern barn, showing the loss of roof and collapse of the gable end. Credit Ian Tillotson

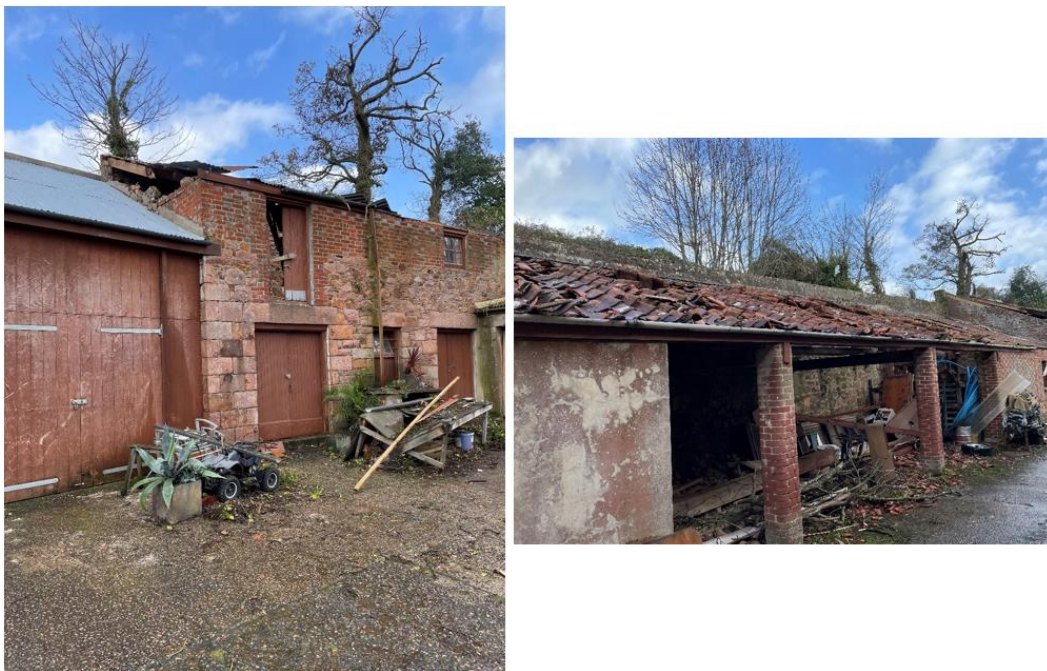
The northern barn (Figure 35) suffered from some roof damage. The adjacent section of barn which had been reroofed and replacement doors fitted approximately two years ago was undamaged.

Figure 35: North barn (Figure 29 'd') showing some damage to roofs and windows. Credit Ian Tillotson
