# The Jersey Tornado

1 November 2023

## Site investigation report by the Tornado and Storm Research Organisation (TORRO)

SI20231101\_Jersey

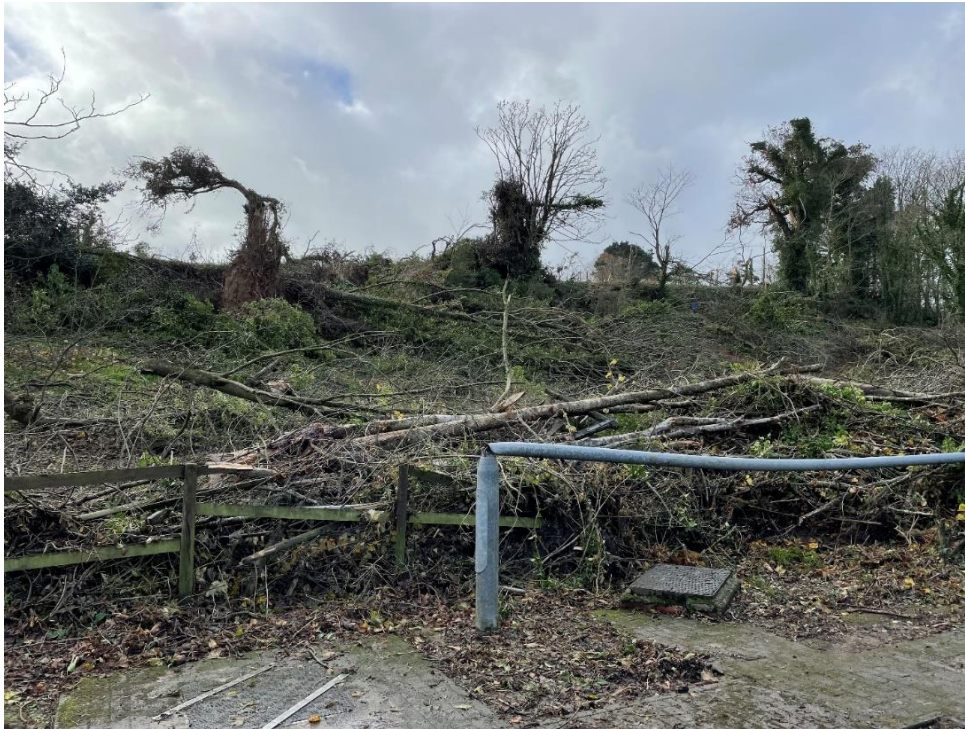
Just across the road from the property (49.2067N, -2.0476W) the trees to the south-west were flattened. A tubular steel communications mast was folded towards the ground in a north-westerly direction (Figure 36). This was rated at **T5**.

Figure 36: Flattened trees and a folded communications mast. Credit Ian Tillotson

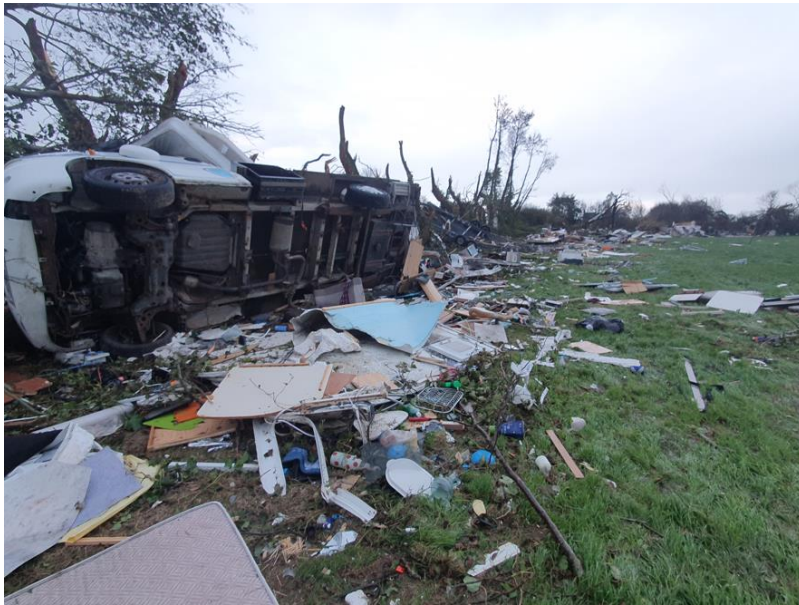
The chassis of a camper van (Figure 38) was displaced around 40m to the south-east of where it started, while the front cabin was found around 80m north-east of its original position. This was rated at **T5**.

*Figure 38: Chassis of campervan amidst general caravan debris*

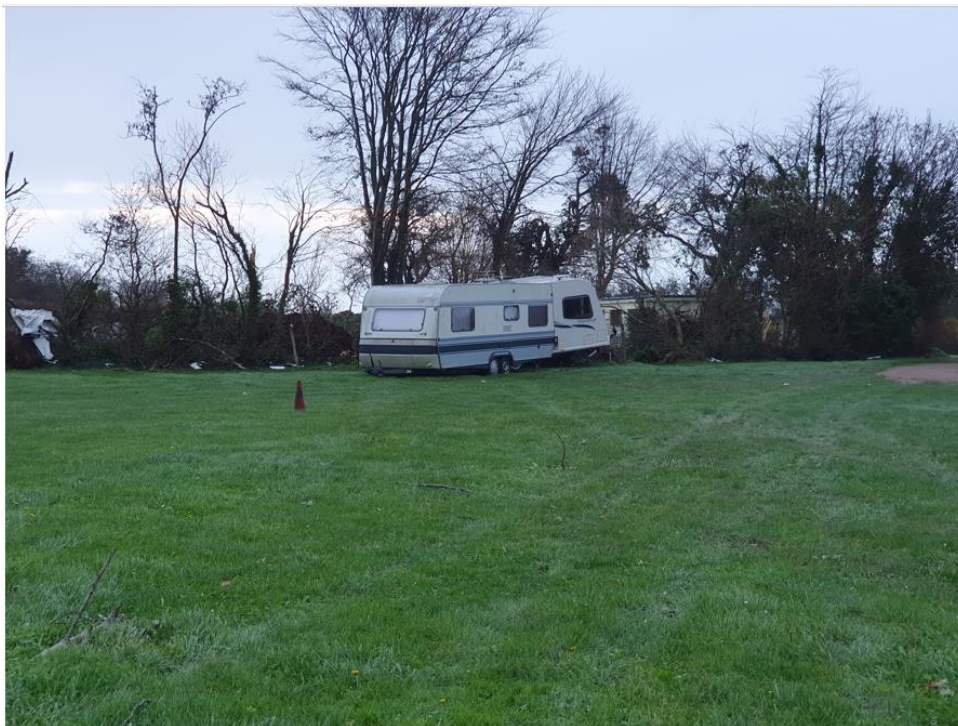
*Figure 39: Caravans displaced from their original position by approximately 50m. Photo taken from estimated start position of the closest caravan.*

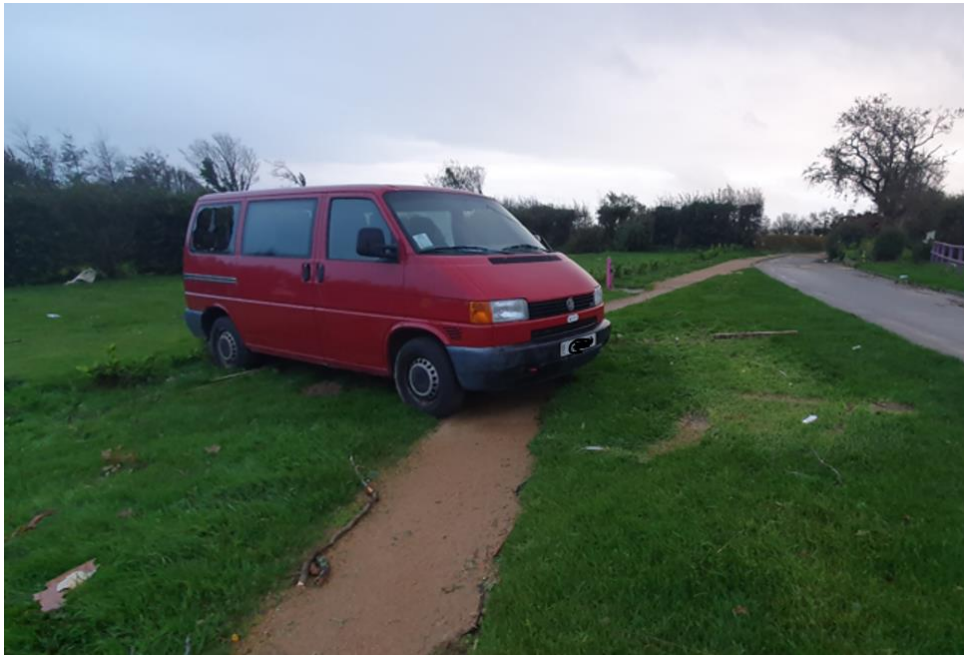
*Figure 40: Van displaced south-eastwards.*

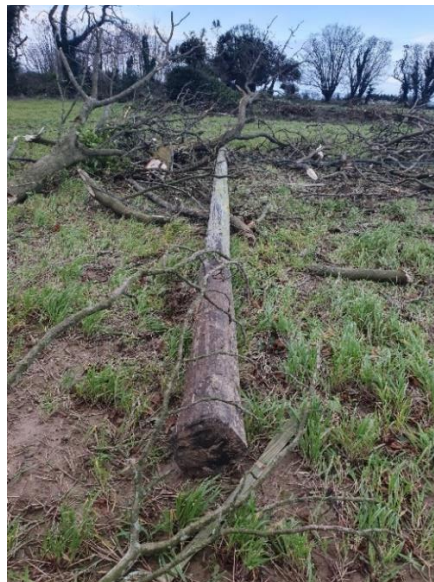
In the field north-east of Beuvelande Campsite several snapped electricity poles were found. More substantially, one had been pulled out of the ground with no sign of drag or disturbance to the ground, landing around 10 metres away (*Figure 41*). This was rated at **T5**.

*Figure 41: Telegraph pole which had been lifted from the ground, landing around 10m away.*

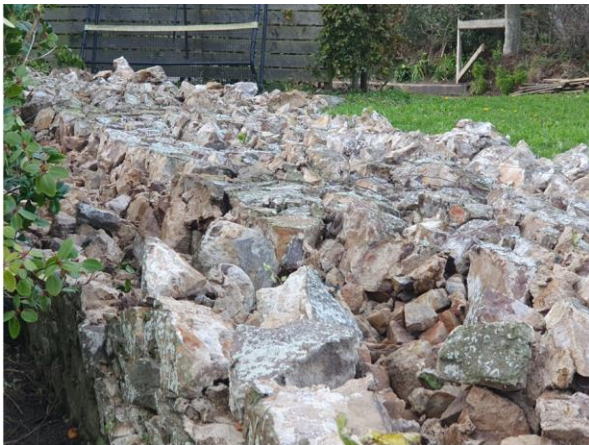
*Figure 42: Remains of 200+-year-old stone wall at a property on the Grand Route de Faldoet.*

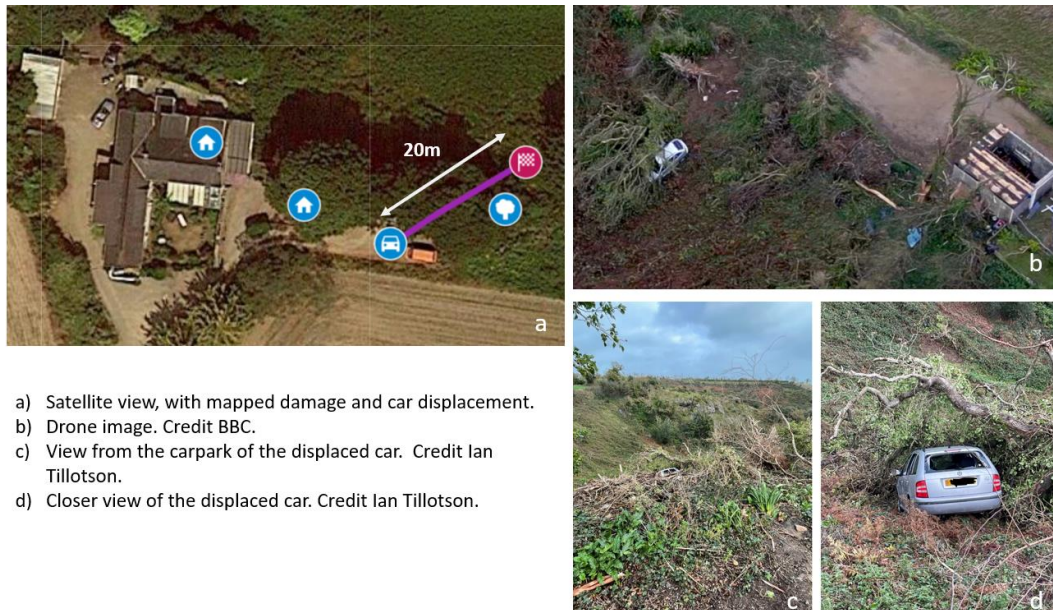
Figure 43: Overview map and photographs of a displaced car at St. Catherine's Woods.

As well as general felled trees across part of St. Catherine's Woods a car was lifted from its original position (49.2191N, -2.0345W) in a parking area to around 20m to the north-east down a slope (Figure 43). The car had its handbrake still deployed. There were no obvious drag marks on the ground and the car roof was not obviously damaged.

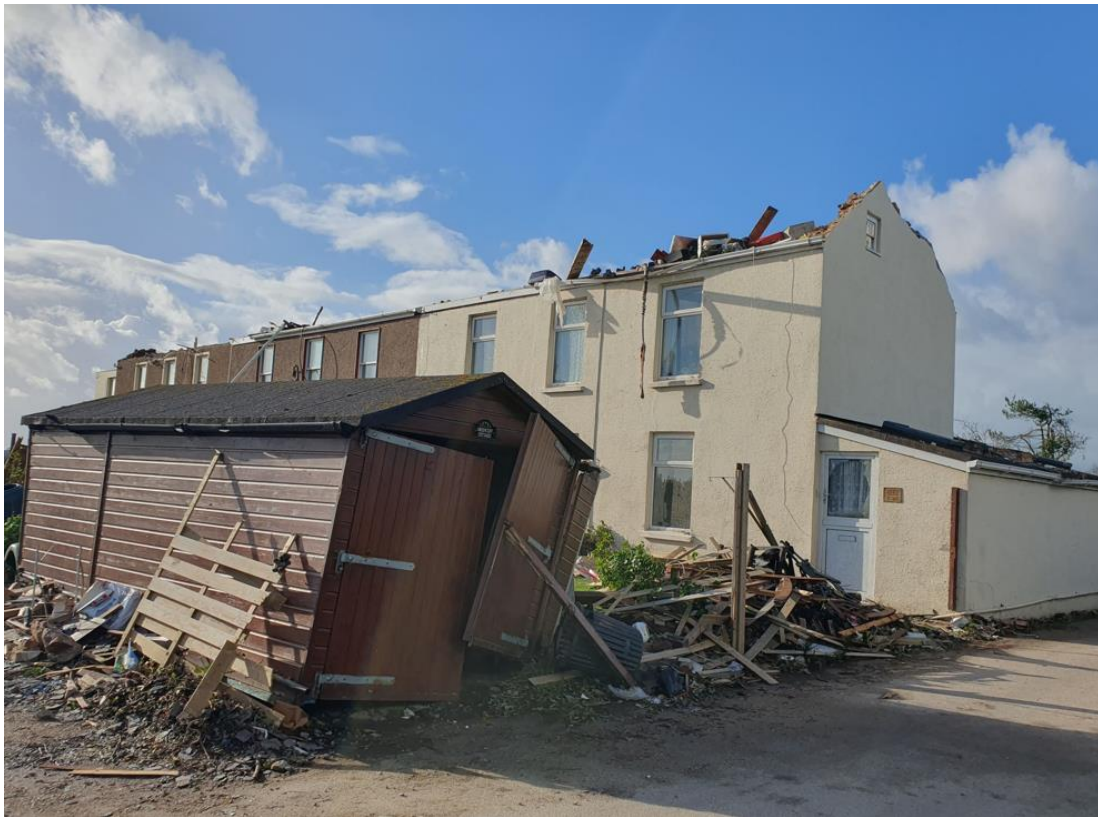
Figure 46: View of western face of Greycliff Cottages, Fliquet.

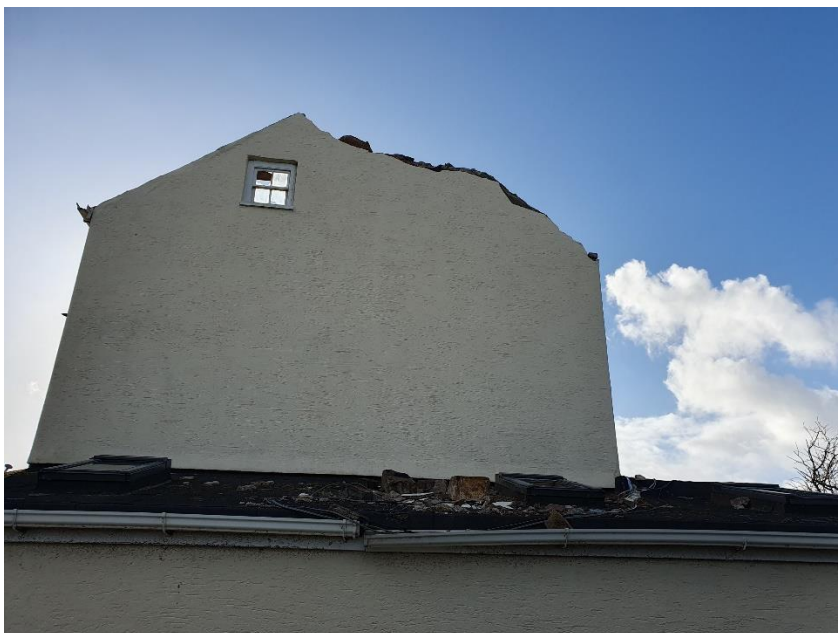
Figure 47: View of northern and eastern faces of Greycliff Cottages, showing partial loss of the gable wall.

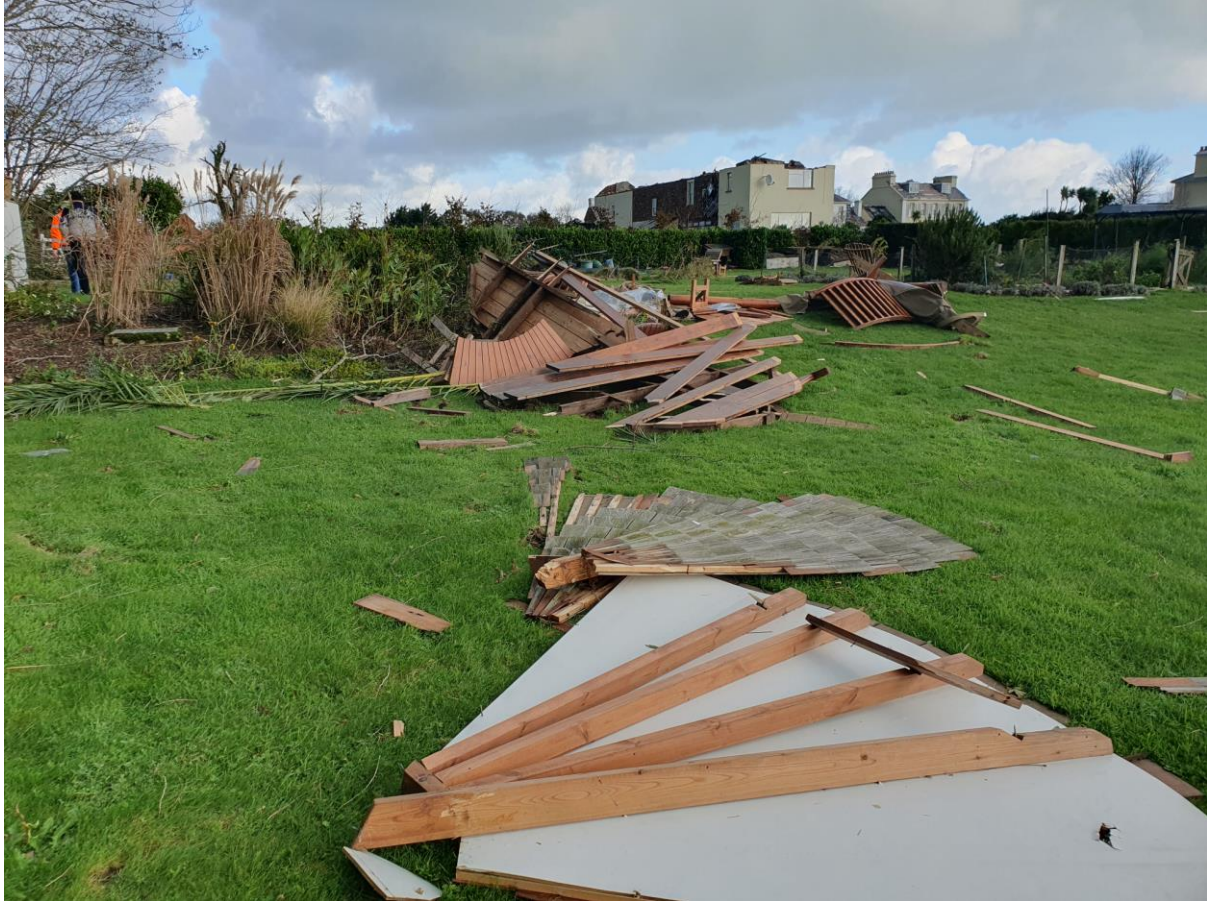
Figure 48: Debris from Greencliff cottages, Fliquet. View looking to the north-west.

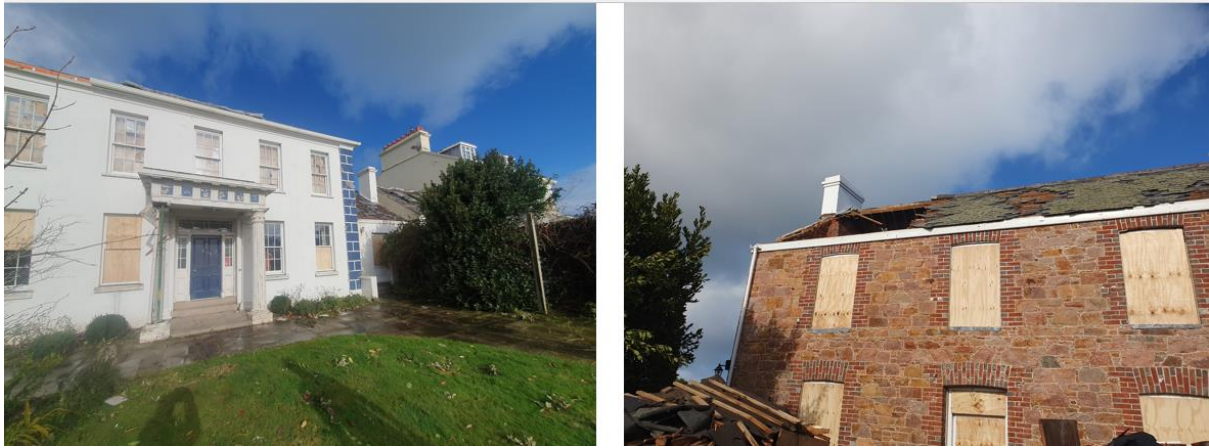
Figure 49: Damage to neighbouring properties in Fliquet.
