# National Register of Historic Places Inventory—Nomination Form

historic STATE NATIONAL BANK BUILDING

street & number 412 Main ST.

city, town Houston N/A vicinity of congressional district

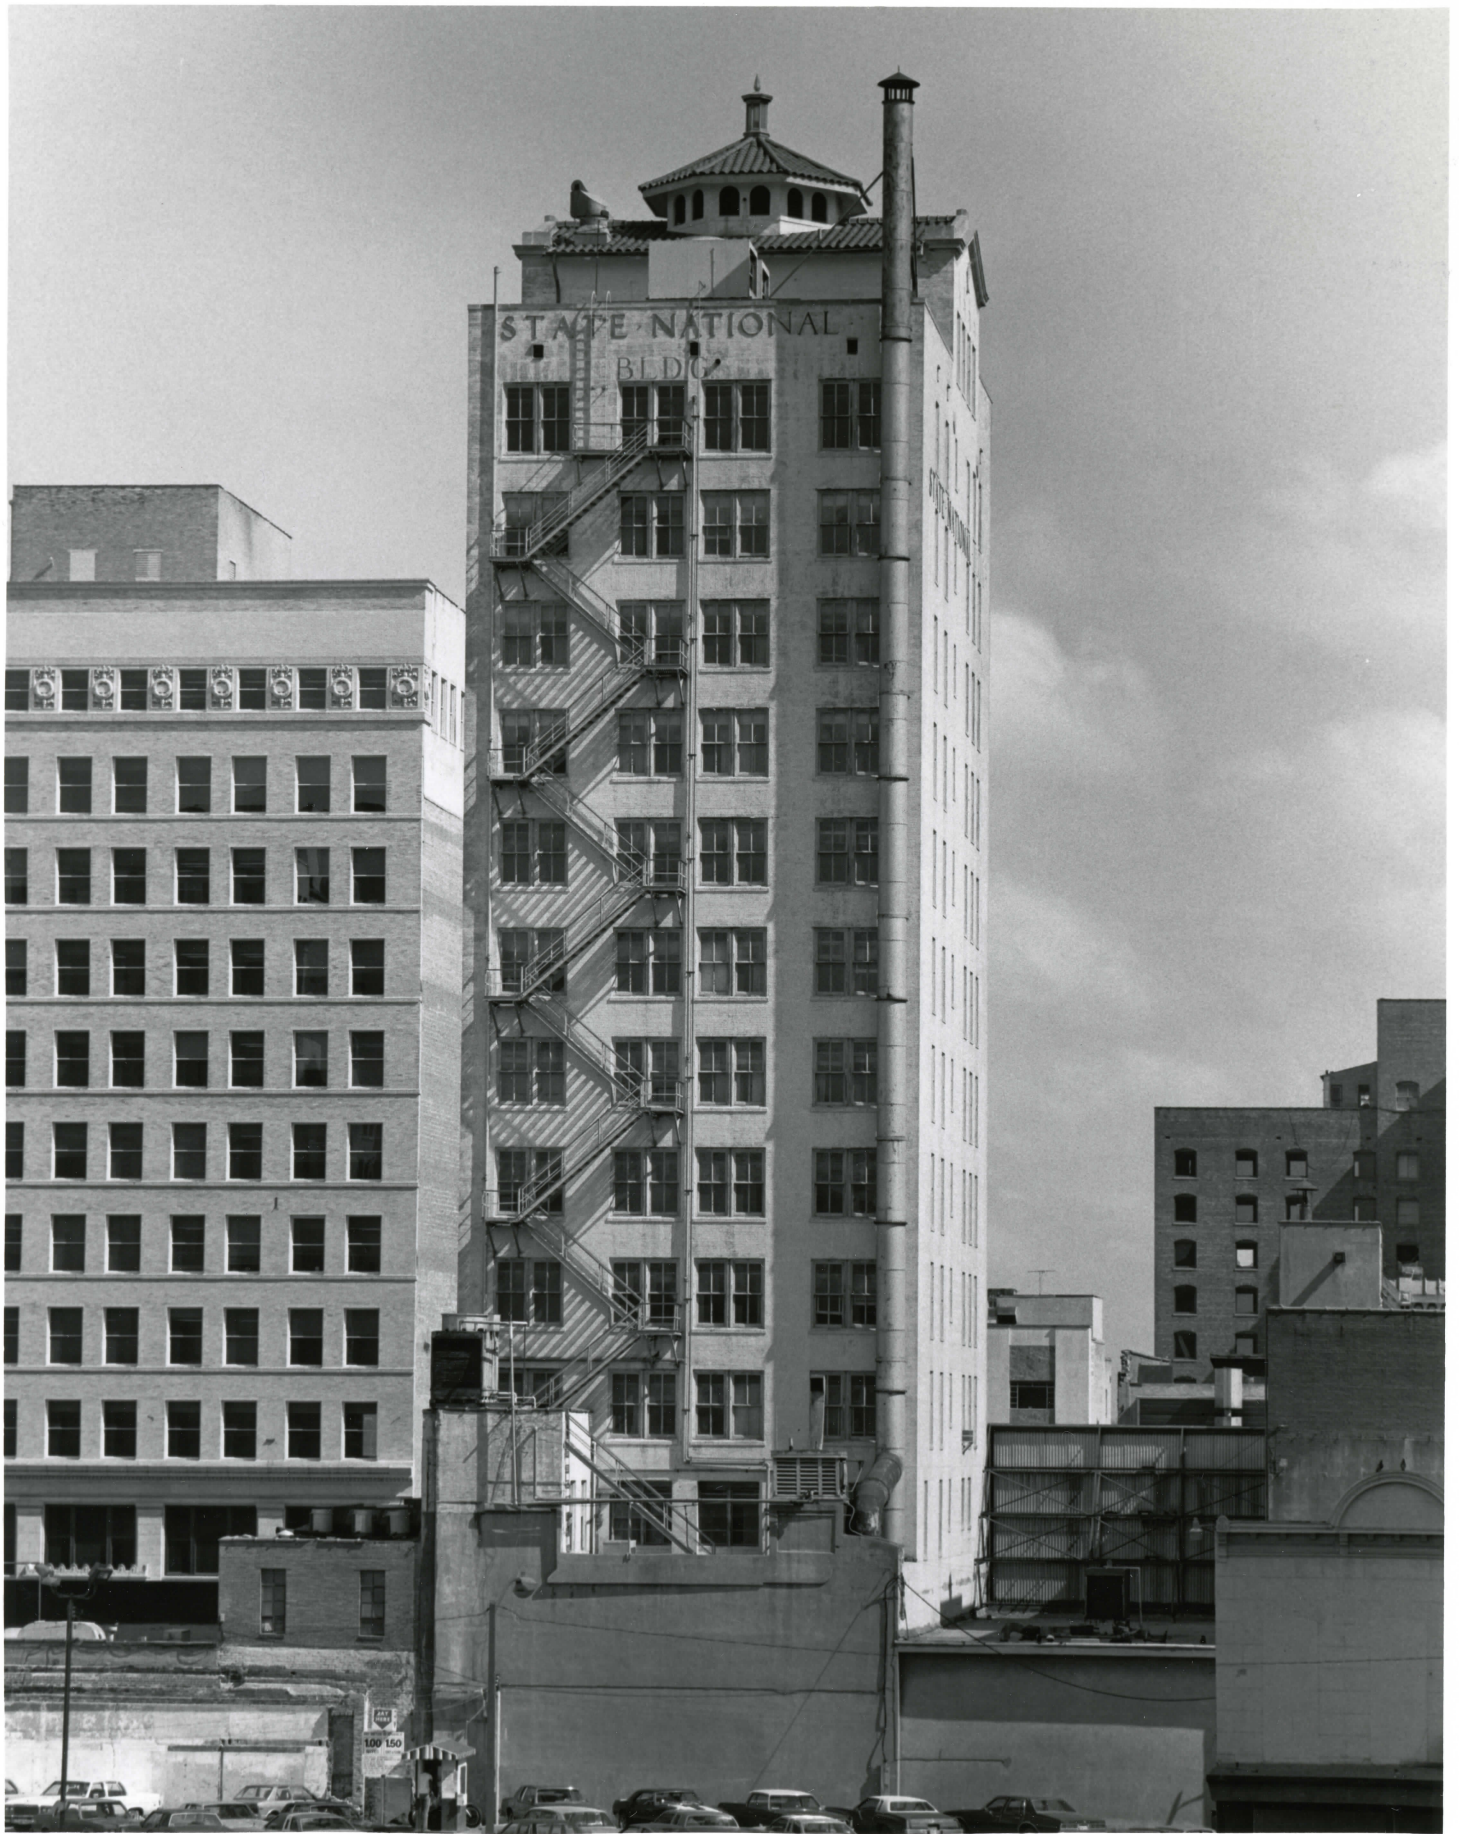
Photo # 2 of 11

Rear (south) elevation

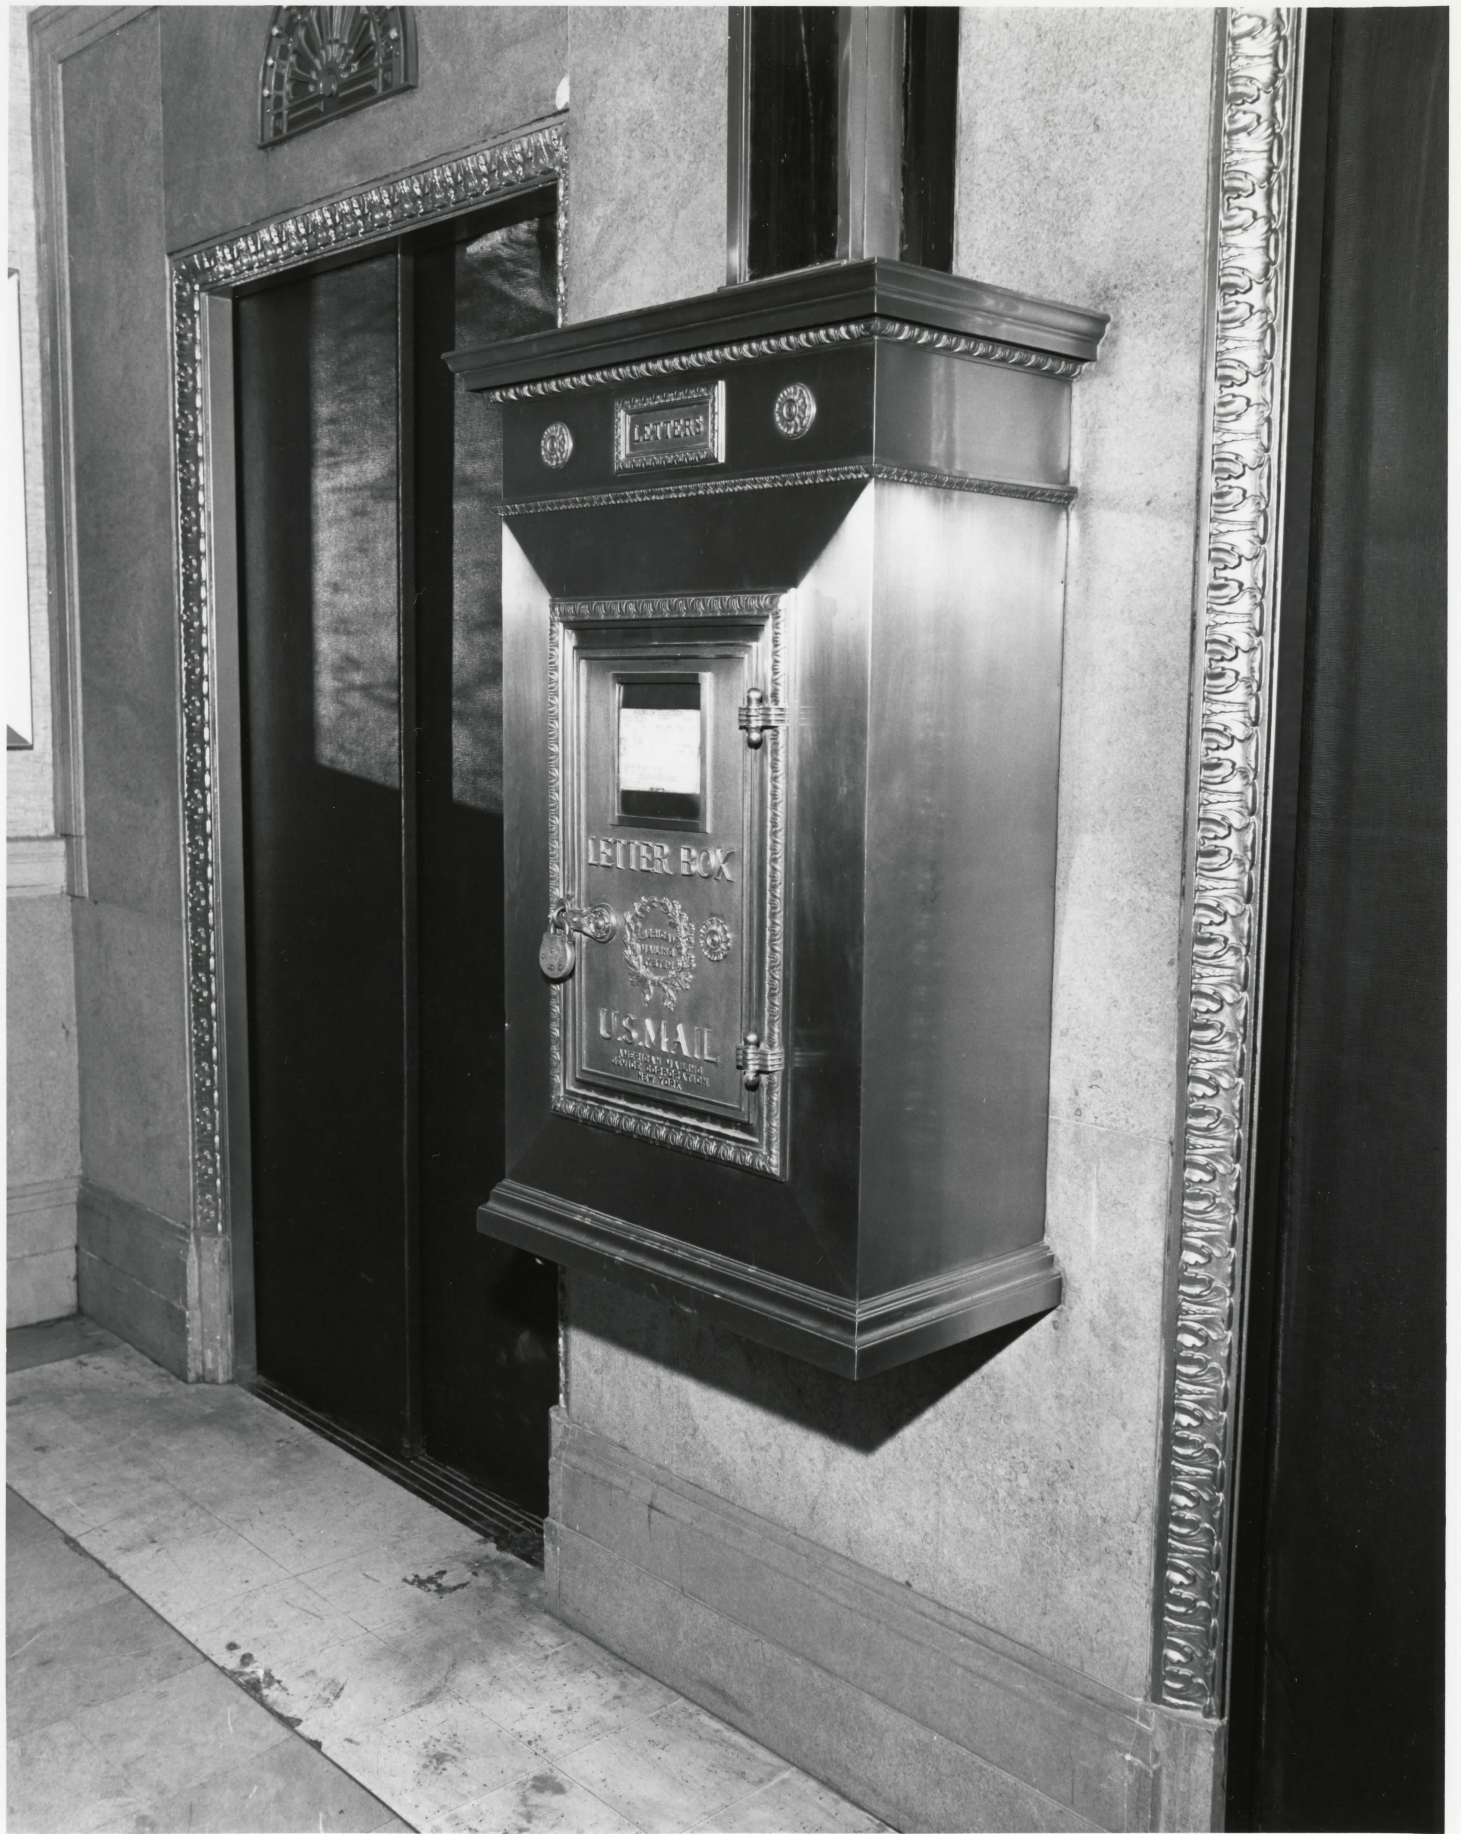
Photo # 4 of 11

Brass mailbox and lock, first floor  
elevator lobby.

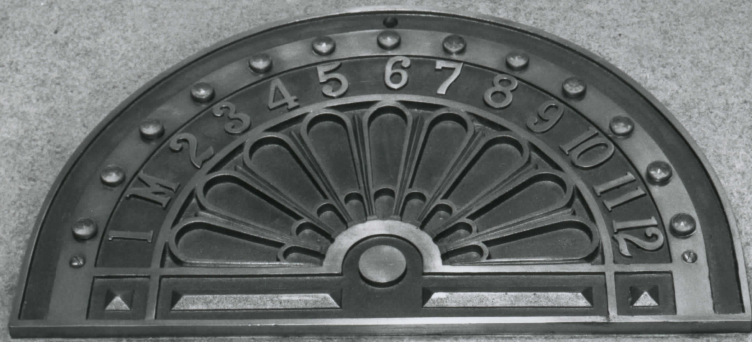
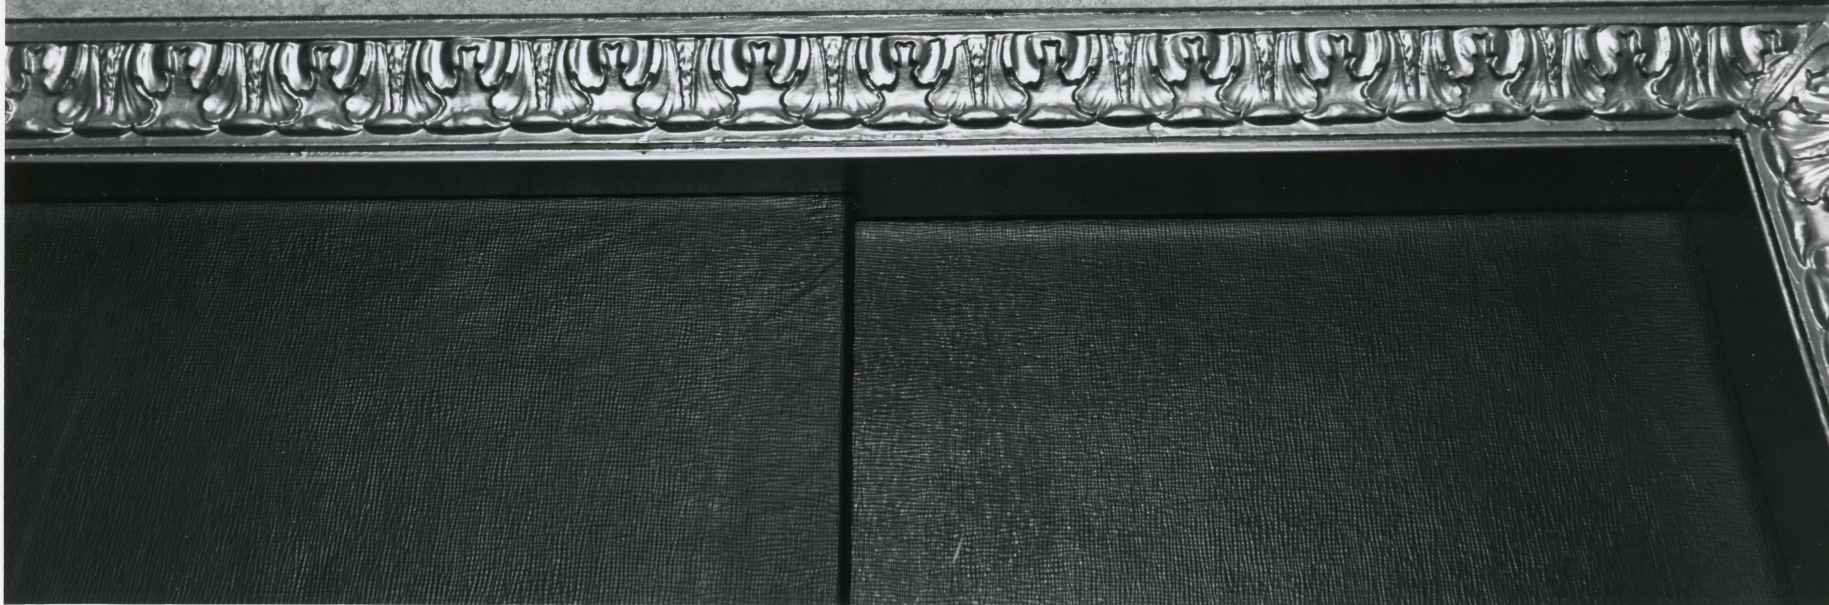
Photo # 5 of 11

Elevator indicator and plaster trim around  
elevator doors, first floor elevator lobby.

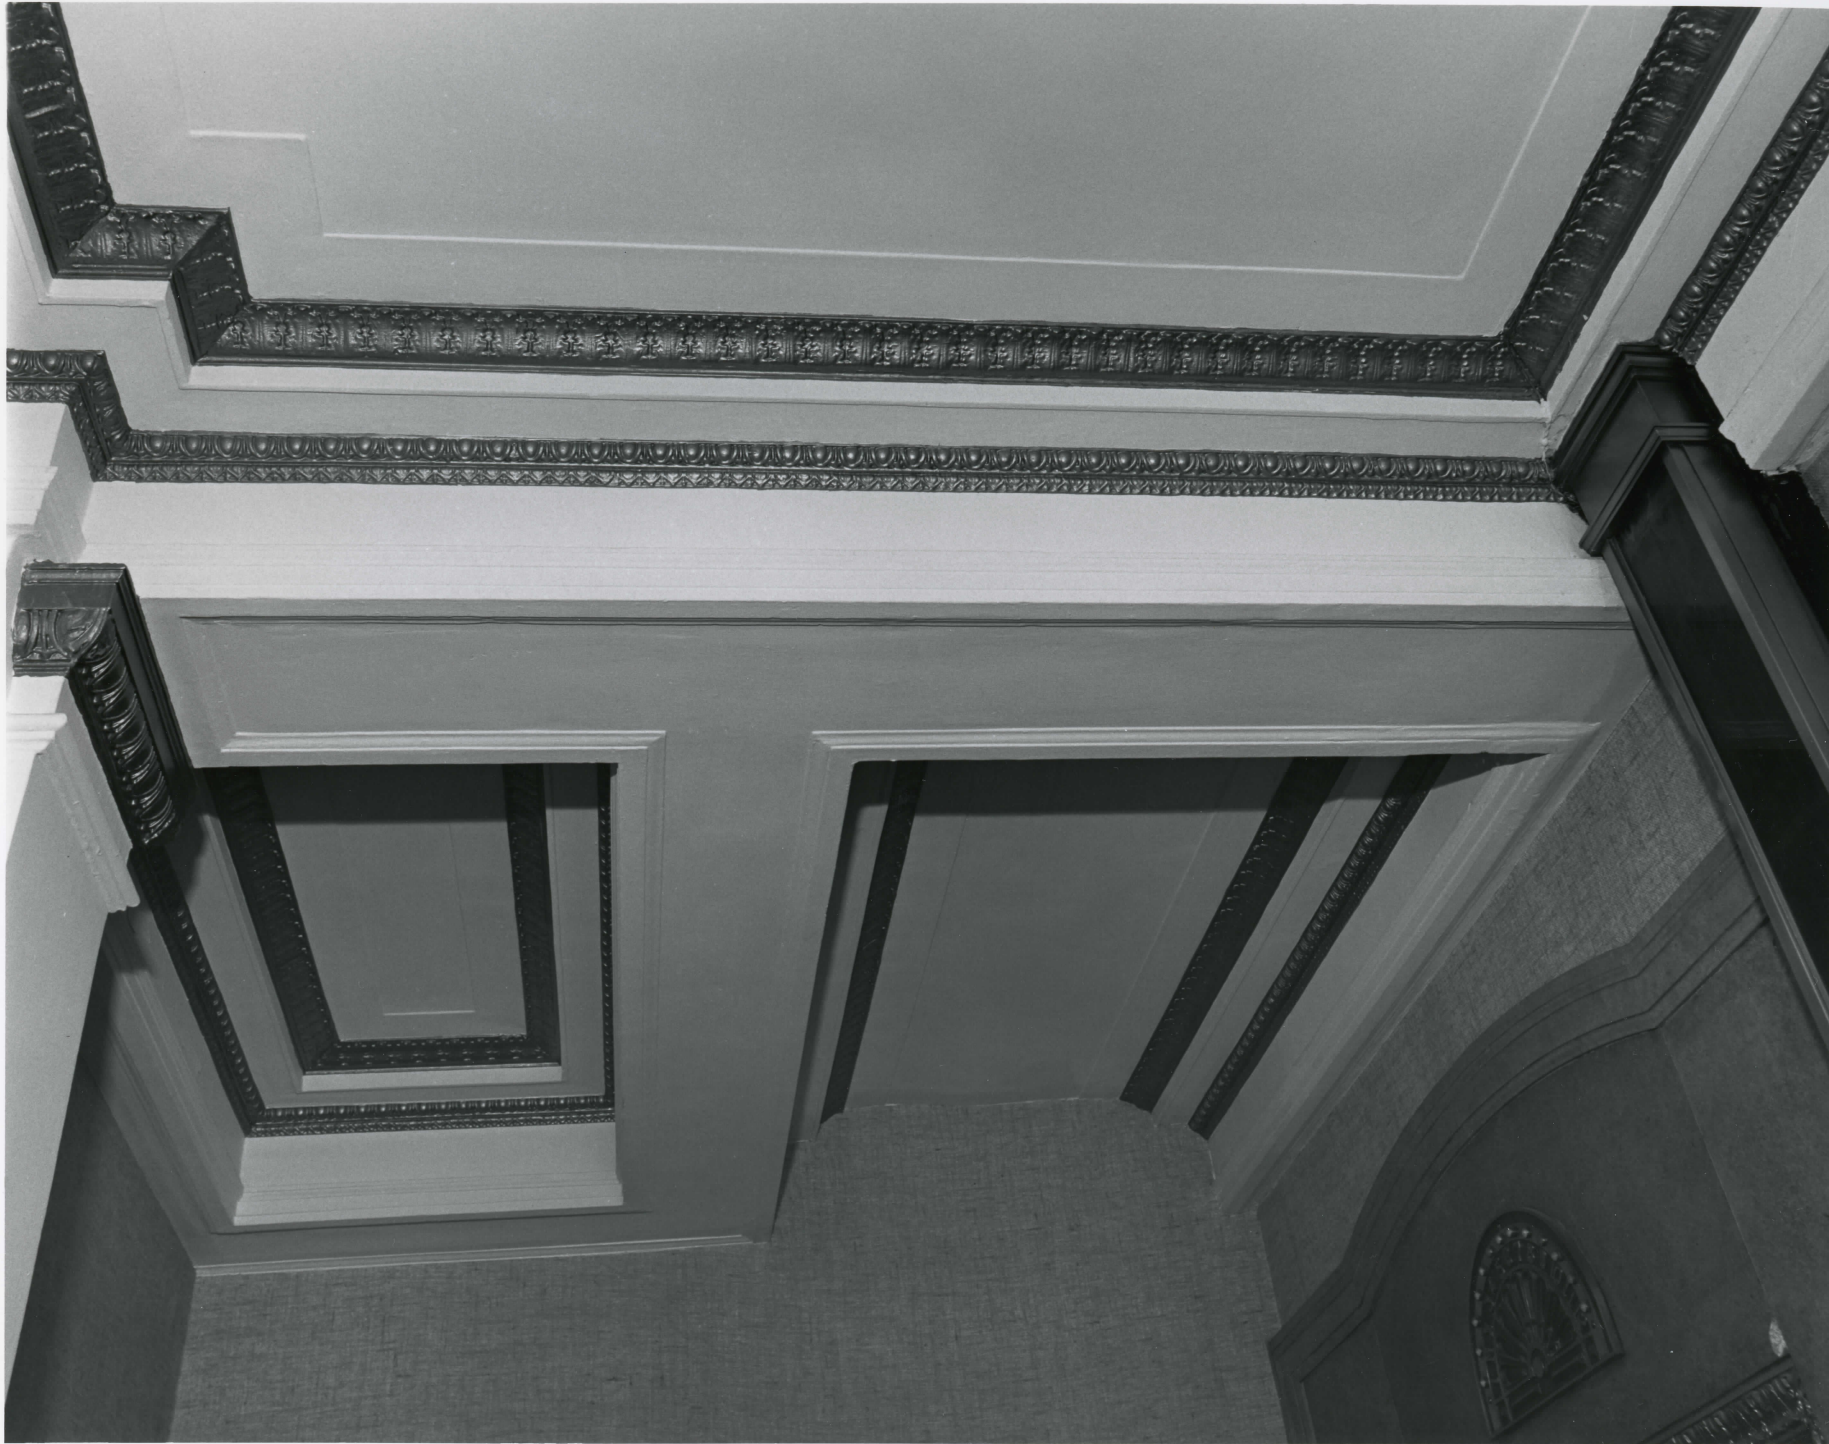
Photo # 6 of 11

Ceiling and molding, first floor elevator  
lobby facing rear (north) wall.

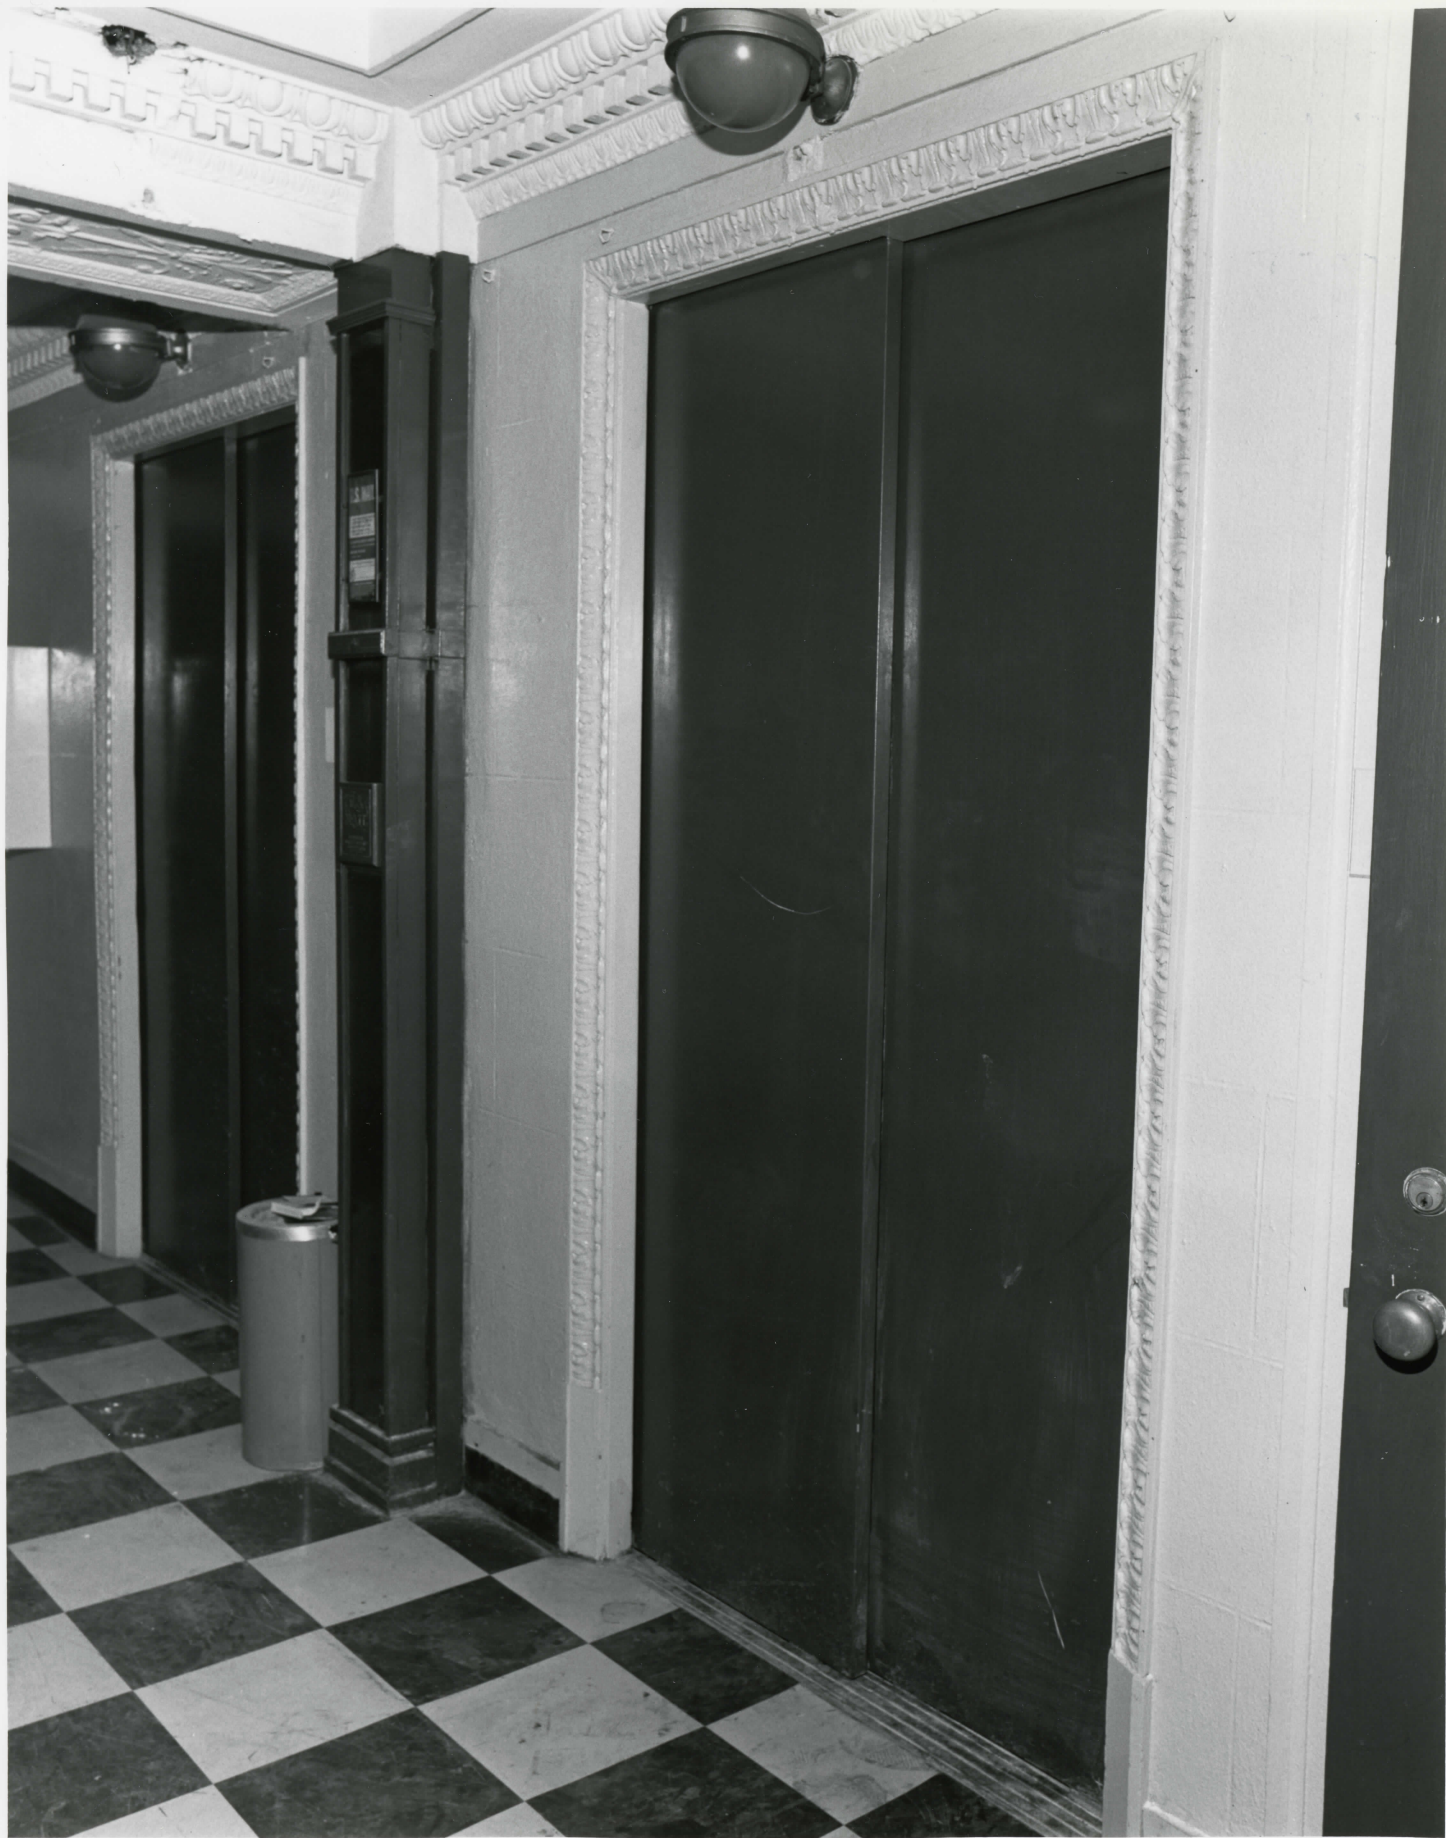
Photo # 7 of 11

Elevator lobby, mezzanine

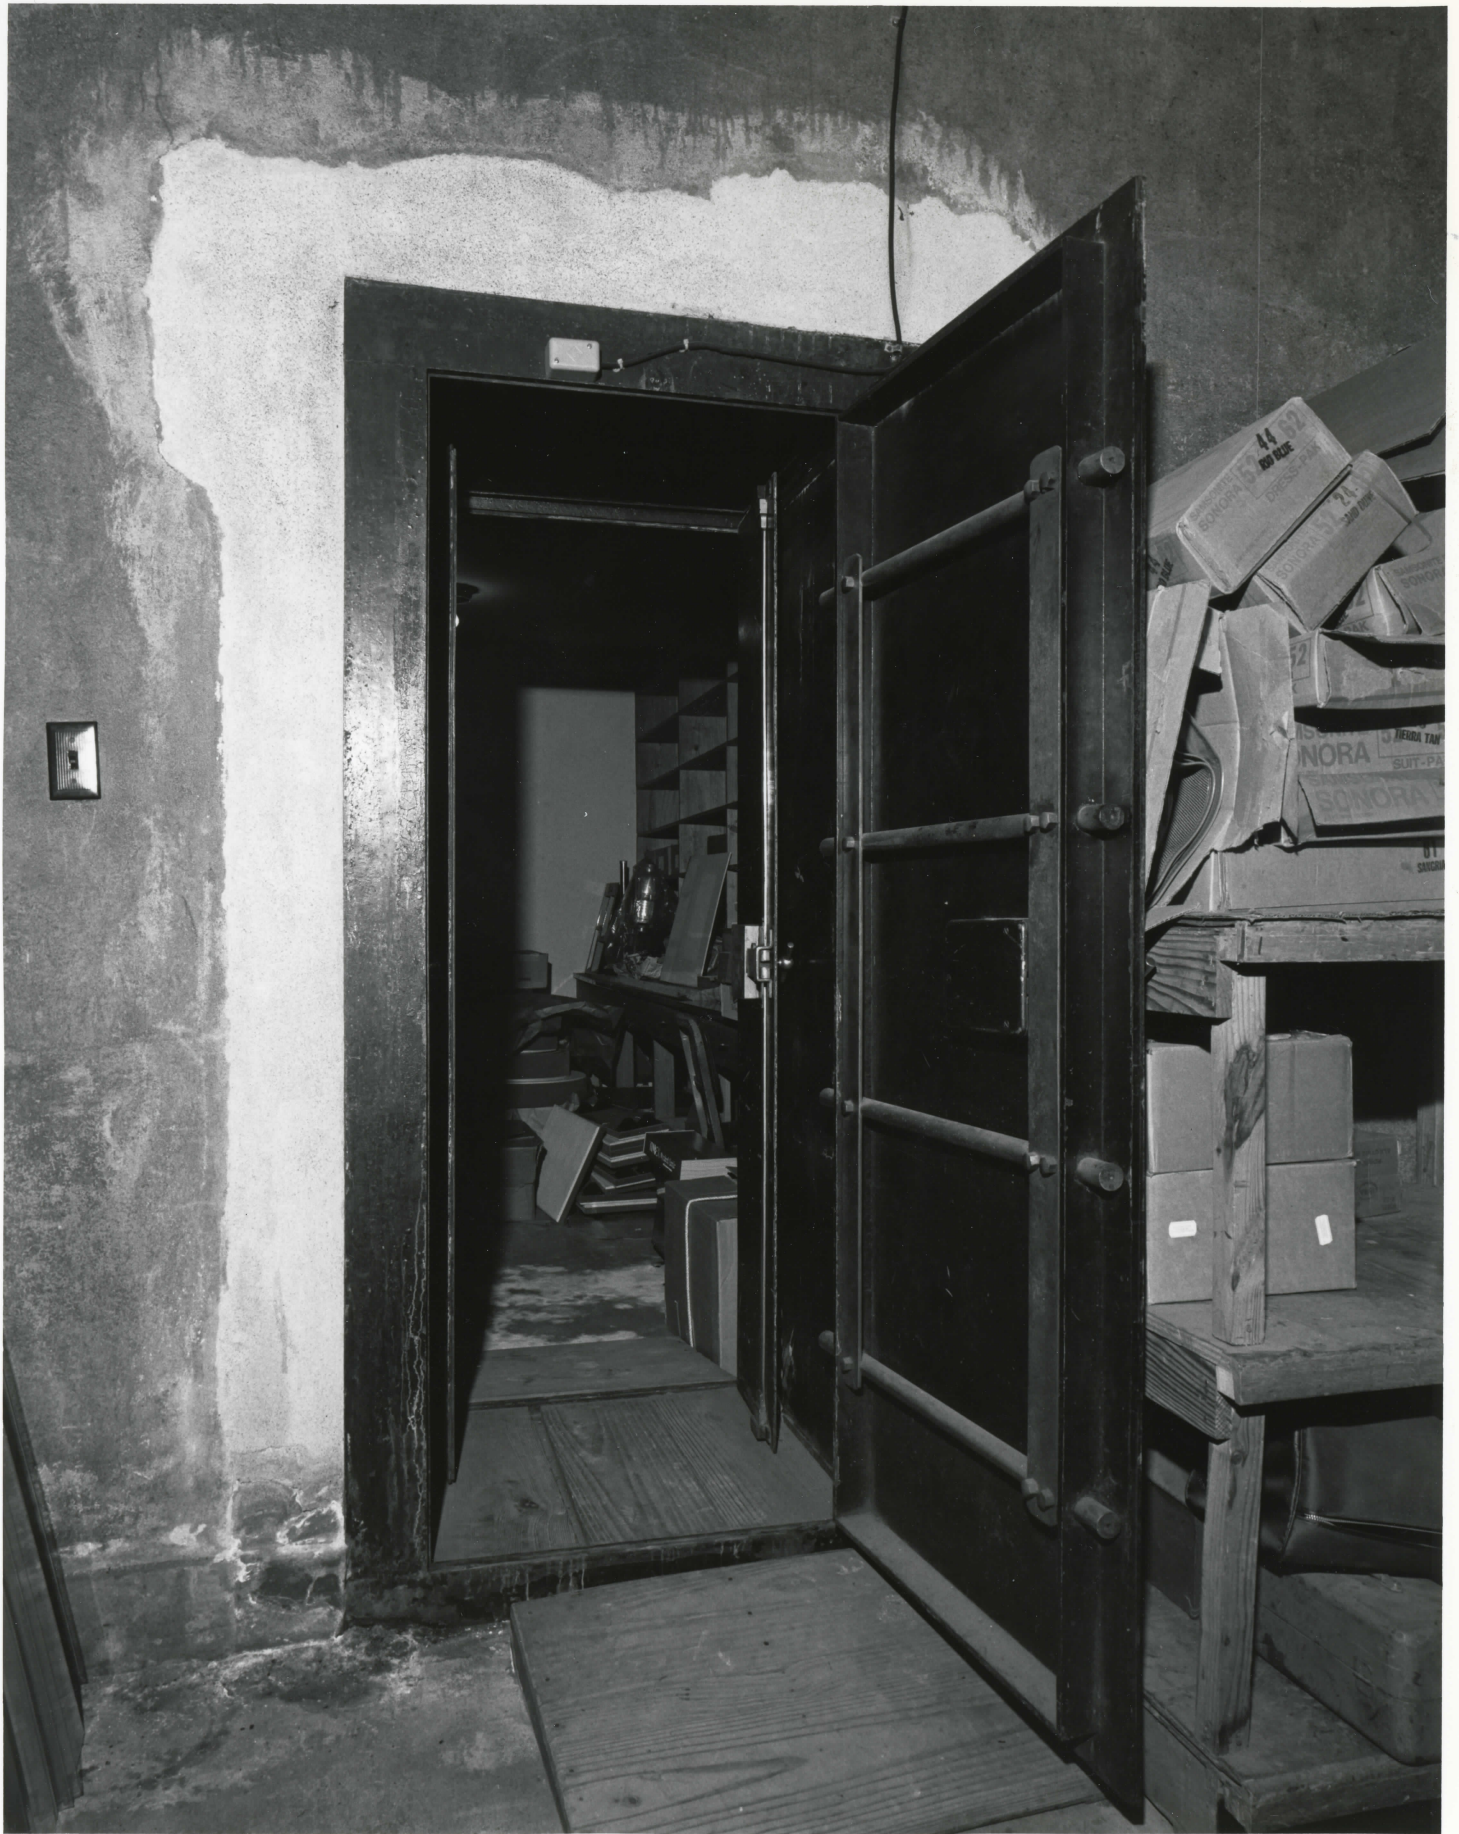
Photo # 8 of 11

Vault door in basement.

The basement of the building houses the boiler room, as well as a conference room and various deposit vaults encased in 20" concrete walls. A marble stair with marble railings connected the basement area to the first floor, at the lobby; another stair is located at the rear of the basement banking area which provided access from the basement to the main banking room on the first floor. A primary feature of the main banking area in the lobby was an oval opening in the ceiling, providing a vertically open space through the mezzanine. Floors of the lobby are marble and concrete; walls are marble wainscot, plaster and imitation stone. A separate building entrance and elevator lobby is provided for access to tenants of the upper floors. The mezzanine floor featured an oval-shaped opening protected by an ornamental iron railing and a wood handrail. Columns projecting into the opening were wrapped with a marble surround. Banking floor walls are imitation stone; floors are monolithic concrete. The directors room on this level was finished in limestone tile flooring, and oak panelled wainscot and plaster walls. The second floor was used for banking offices. A glassed opening enclosed a portion of the oval-shaped opening to the main banking lobby on the first floor. Partitions on this level were 2" thick plaster. Corridor floors are terrazzo. Walls are marble wainscot and plaster. Office floors are monolithic concrete. Typical tenant-occupied floors 3 through 12 were finished with plaster walls and ceilings. Floors are cement except in the corridors and toilets, where the floors are terrazzo. Corridor and toilet walls have a marble wainscot and plaster finish. A red terra cotta pitched tile roof covers the penthouse and an octagonal cupola rises from the penthouse upon which a bronze

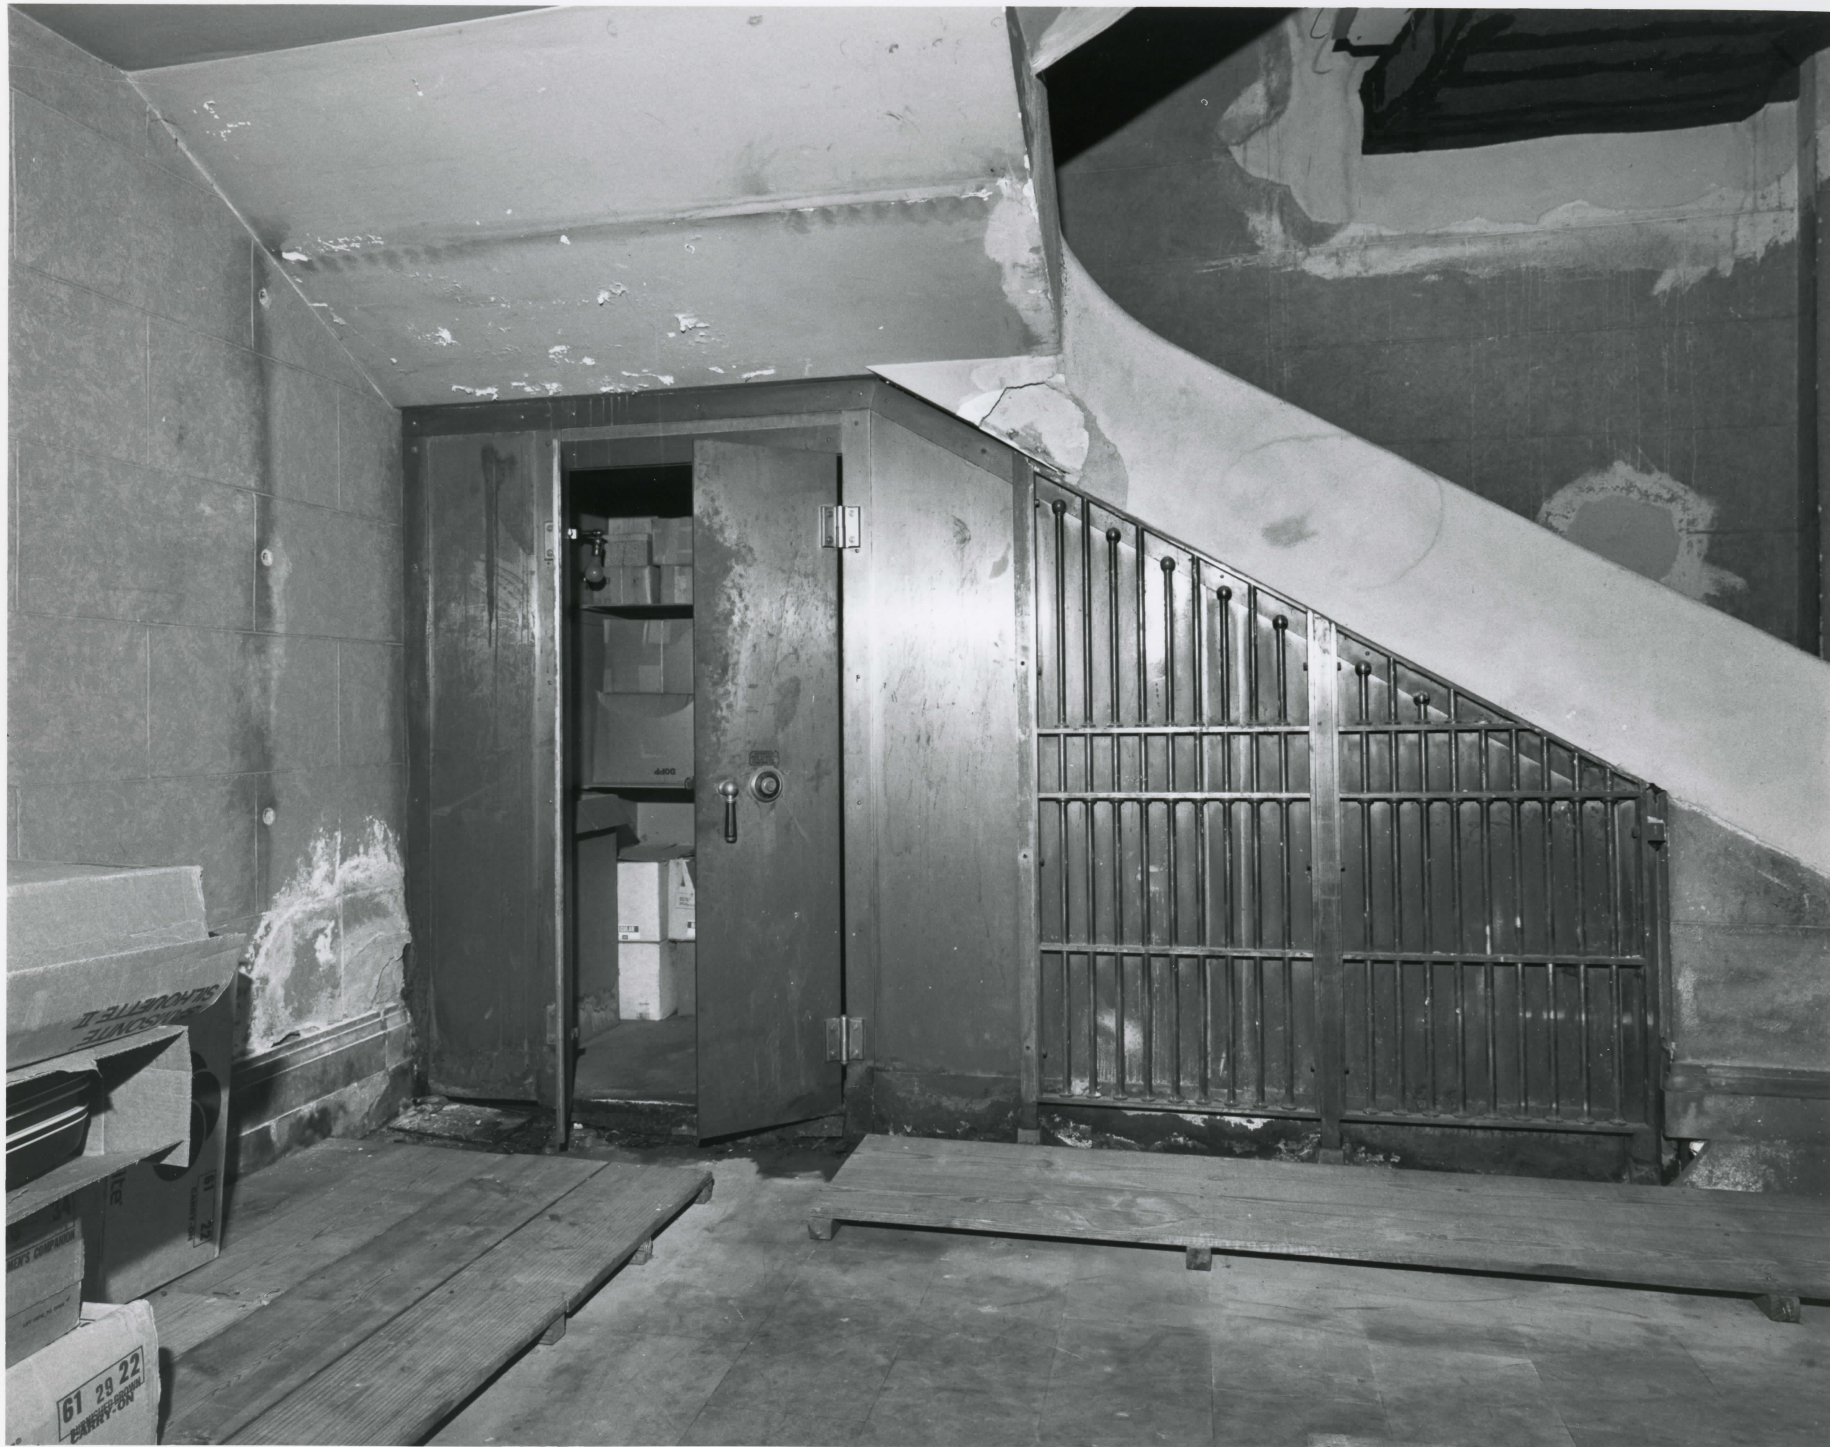
Photo # 9 of 11

Vault door and bronze grillage under stairs  
basement to first floor, east wall (also  
shows marble floor in basement)

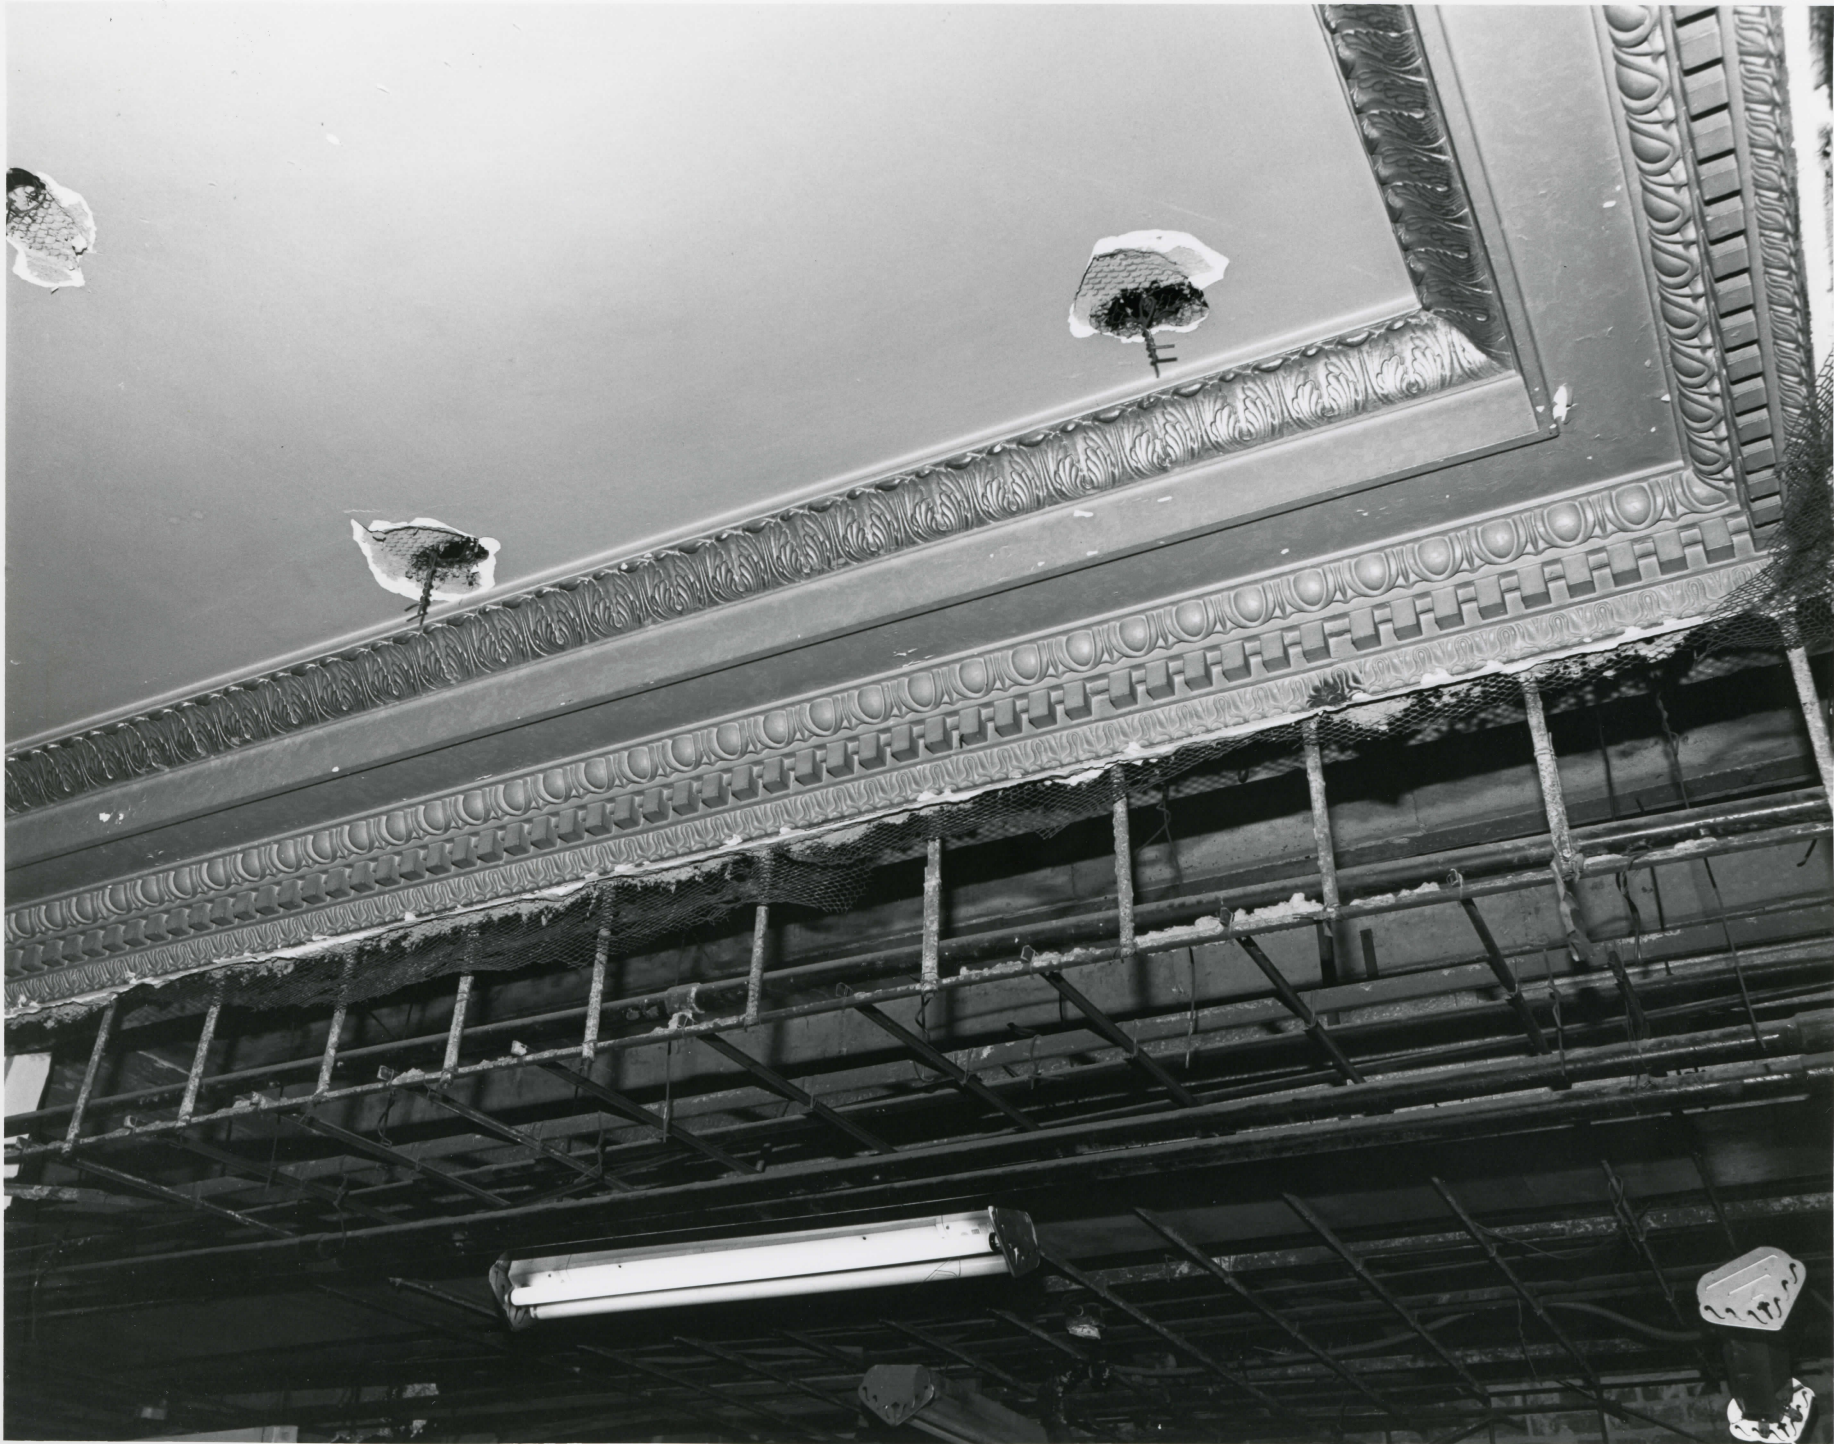
Photo # 10 of 11

Egg and dart mold and plaster cornice trim,  
mezzanine.

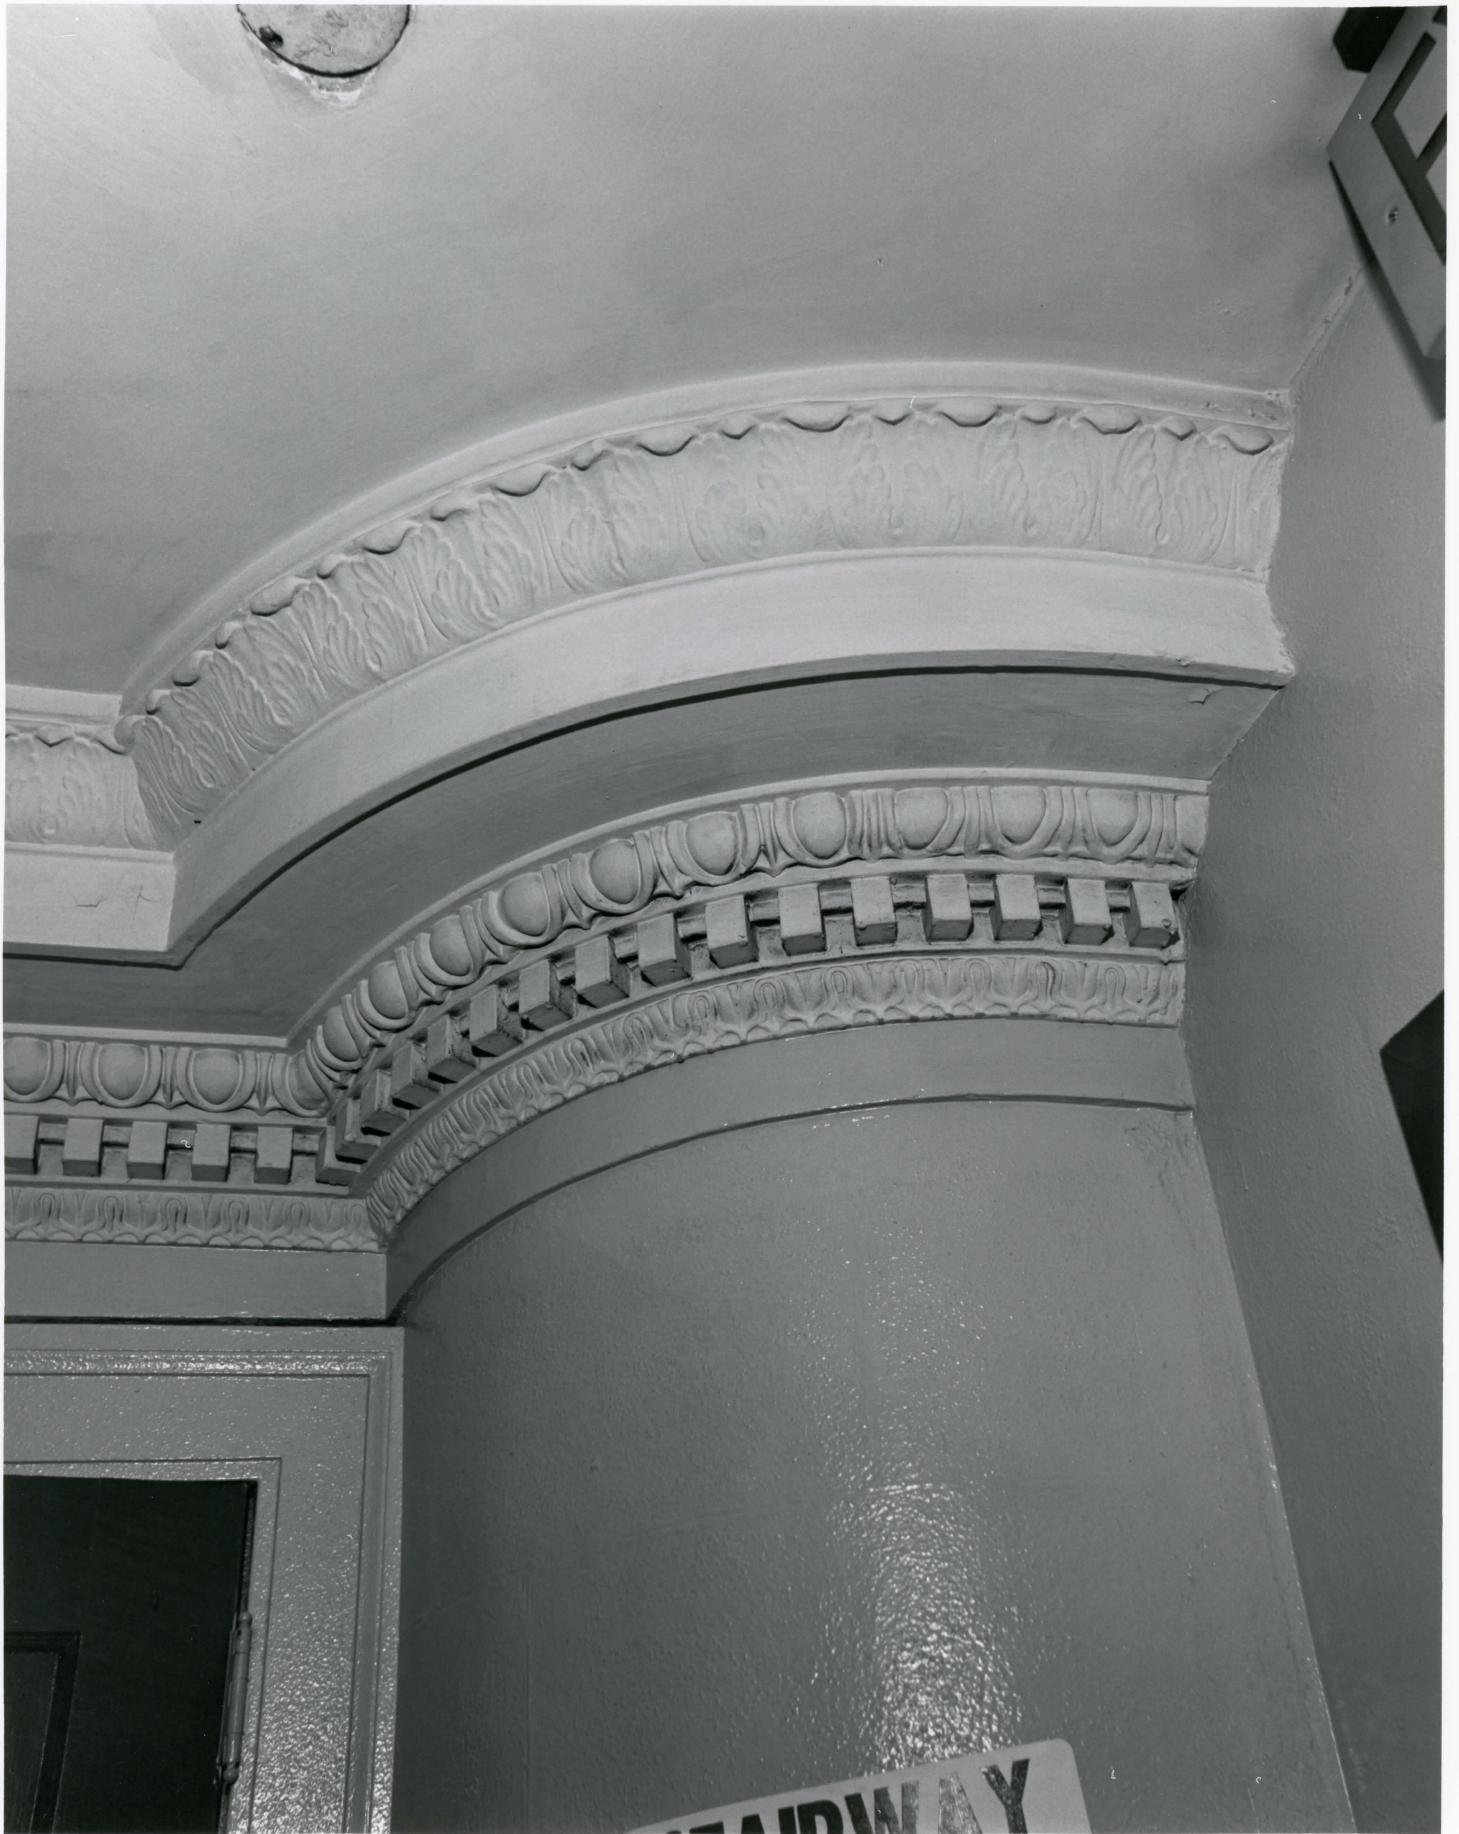
Photo # 11 of 11

Column cap and ceiling mold trim at  
mezzanine.
