# The Jersey Tornado

1 November 2023

## Site investigation report by the Tornado and Storm Research Organisation (TORRO)

SI20231101\_Jersey

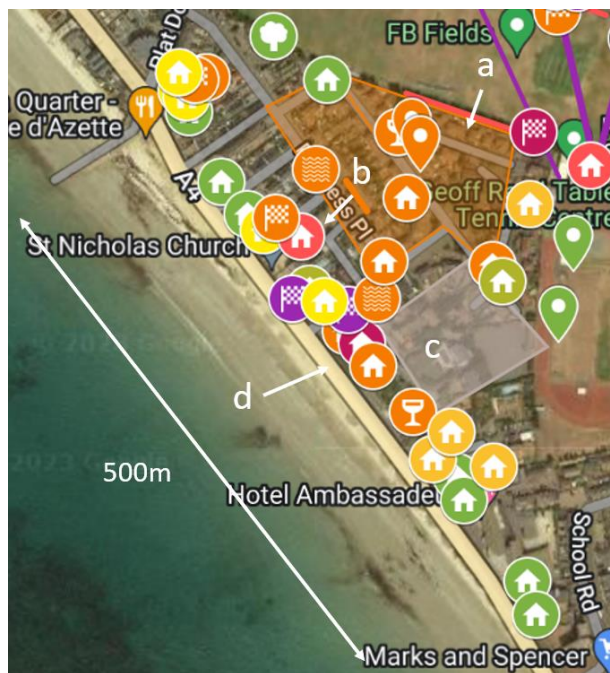
Figure 4: Map of damage points in St Clement around the coast and into Florence Boot Cottages.

- a) Florence Boot Cottages
- b) St Nicholas Church
- c) Not surveyed
- d) Severely damaged home on St Clement's beach front

Damage was found across a 550m swath along the seafront. The most eastern point (49.1697N, -2.0849W) consisted of some missing ridge tiles on a house roof. A nearby brick wall was also found collapsed towards the west. It is unclear whether the damage was definitely tornadic at this point, but it is considered likely as no damage was evident further east along the seafront near to this location.

To the west of this point, at (49.1708N, -2.0854W) a house was spotted with general roof damage on its south-east facing side and was categorised as **T2** damage intensity. Nearby, to the north-west a single layer garden wall had collapsed to the south and north. A car parked close by had multiple windows smashed and dents in the rear nearside door. It was determined that the blocks next to the car were probably intended to hold down a protective tarp rather than having travelled from the wall a few metres away (Figure 5).

To the west of this point, damage became abruptly more intense with the south-western face of properties having lost most or all of their windows on the beachfront face. More substantial roof damage was evident along here and damage was rated at **T3**.

A two-storey brick built residential home (49.1717N, -2.0869W) suffered severe damage to the north-western end of the upper floor. Collapsed walls revealed the interior of the building. The walls fell to the north-west. The roof also appeared to be missing (Figure 6). This damage was rated as **T5**.

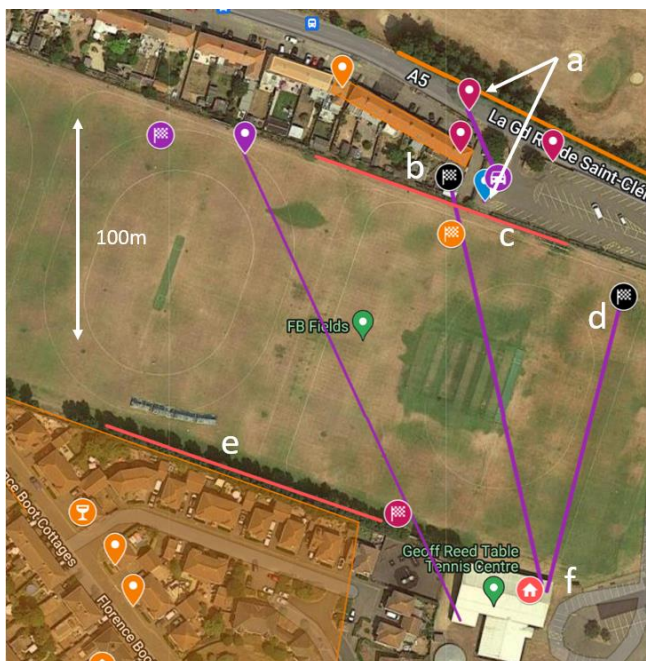
Figure 13: Map of some of the damage found in this area. Most individual damage and debris points are not indicated. Purple lines denote debris travel.

- a) Large recycling bin bounced off a car before landing in the road.
- b) Large beam penetrating lawn. An internal bedroom wall blew down.
- c) 100m long fence damaged.
- d) Pile of debris including 5.4m long wooden beam.
- e) 100m long fence buckled. Severe tree damage and twisted metal structures found here.
- f) Geoff Reed Table Tennis Centre

At the south-western end of Florence Boot Playing Fields, the Geoff Reed Table Tennis Centre (JE2 6QN) was badly damaged (Figure 14), especially across the south-western end where approximately 1/3 of the sheet metal roof was lost. Drone footage shows the damaged front wall fell forward.

Spread across the field was a 200m wide swath of debris. Intense damage to trees and the southern and northern boundary fences occurred for 100m across both sides of the field, indicating the strongest core area of wind in this part of the track. The metal fence posts were bent north-eastwards in places and metal structures were torn and twisted, indicating **T4** damage. In the carpark to the north of Florence Boot Playing Fields, a large metal clothes recycling bank rolled onto a car before landing on the road approximately 40m from where it started. A lamp post, apparently hit by debris, folded to the road. Both of these were assigned **T5**.

At the same home where the large wooden beam landed (49.1745N, -2.0847W), there was **T3** roof damage. A resident of these cottages (pictured in Figure 15) was clearing up damage and was happy to show some of the damage that occurred. He described lying in his low-profile bed, when suddenly the window shattered, and debris flew just above him. He said that “Tiles and stuff like that shot like a cannon across the room.” His internal bedroom wall blew down. He said that he left the room rapidly and sheltered downstairs.

Structures around Florence Boot Playing Fields exhibited damage consistent with **T3-T5** and the throw of wooden beams from the Geoff Reed Table Tennis Centre was assigned a **T6** rating.

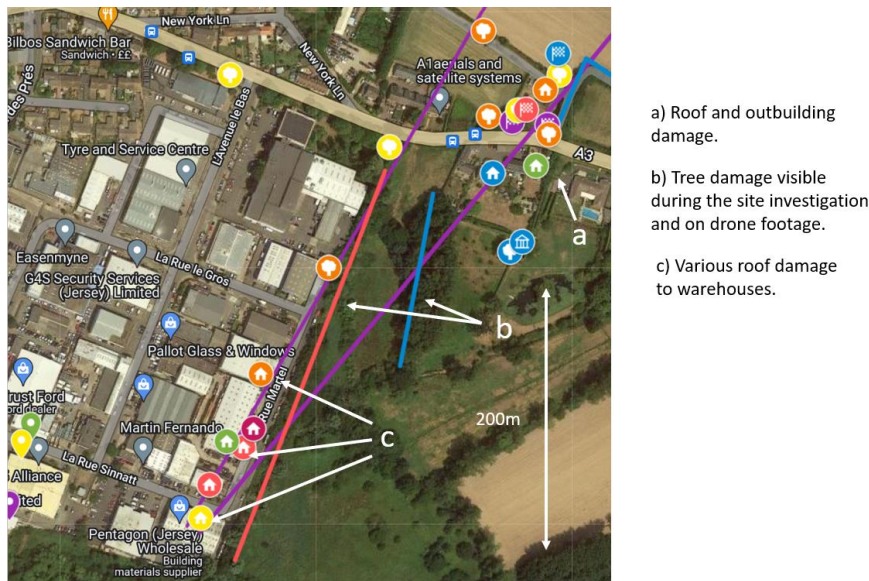
Figure 19: Map of damage points at Rue Des Pres Trading Estate

The south-eastern corner of the Rue Des Pres Trading Estate (JE2 7QR) was hit by the tornado. There was substantial damage to warehouses and other buildings. One warehouse (49.1802N, -2.0776W) lost almost half of the metal sheeting from the roof. Metal sheeting from this warehouse and others was found in various locations along the track, wrapped around trees and in hedges up to 1.4km away (Figure 20).

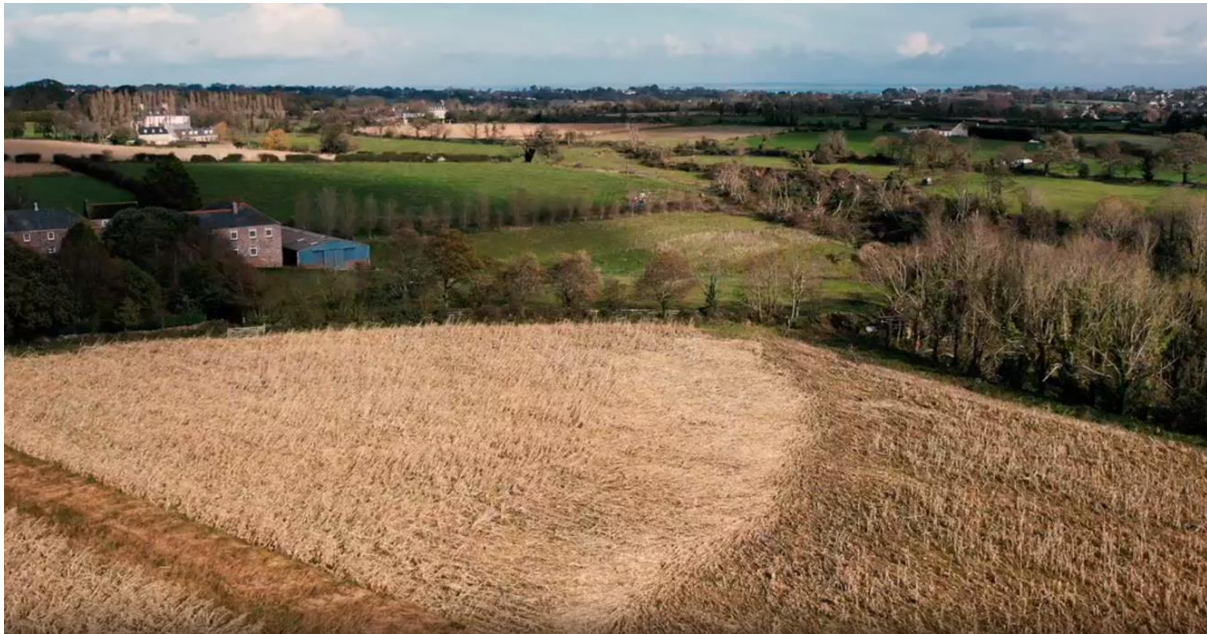
North-east of Boulivot drone footage supplied by BBC camera operator Tracey Cahill showed the path of the tornado through a maize field (around 49.1931N, -2.0626W)

*Figure 26: Path of the tornado through a maize field, looking south-southwest. Credit Tracey Cahill.*

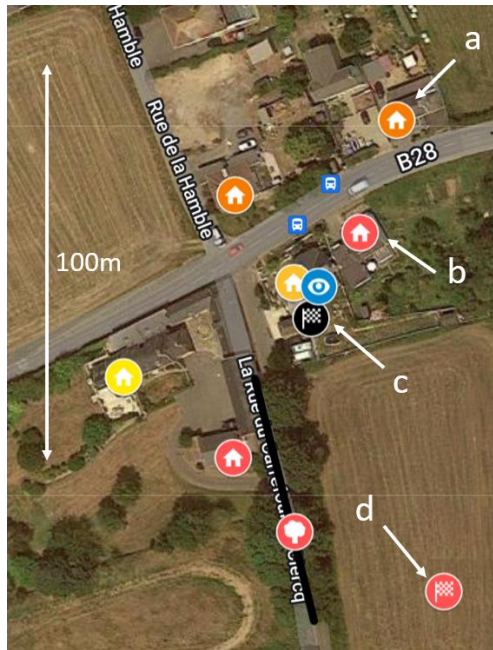
Figure 27: Damage to properties on the La Route de La Hogue Blie.

- a) Missing flat roof.
- b) Embedded branch in tiled roof.
- c) Embedded tile in render.
- d) Tree debris.

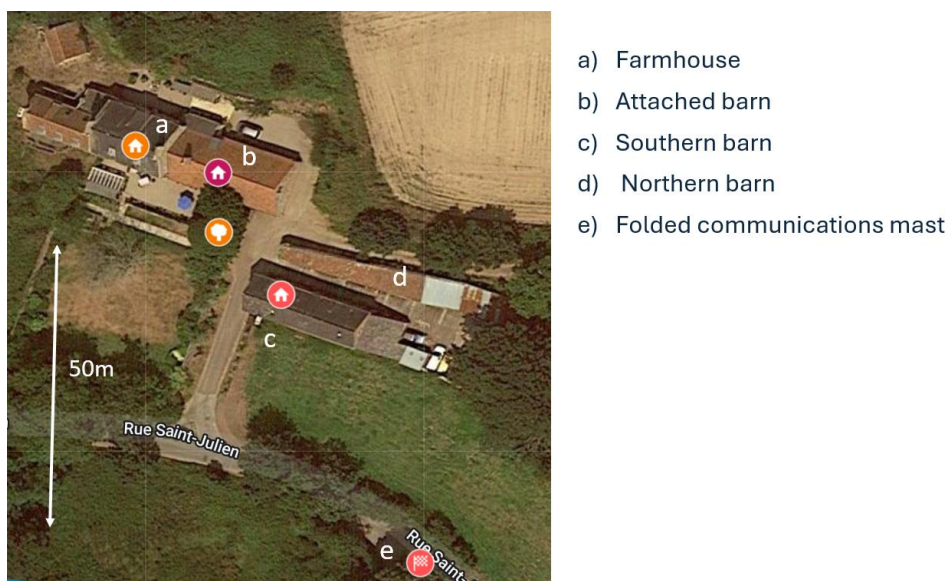
Figure 29: Residential and farm buildings on Rue Saint-Julien

This location was visited by Jersey resident Ian Tillotson on behalf of TORRO on 19 November 2023. All locations refer to those marked in Figure 29. The farmhouse (marked ‘a’ on the map) lost tiles from the unfelted roof and the two chimneys were partially toppled. There was significant roof damage from the toppled chimneys. Some of the windows blew in. Internal doors inside the farmhouse now jam and it was felt that there had been movement to the internal walls. The kitchen lean-to extension appeared to have shifted as there was internal cracking at the ceiling and wall corners. This damage was rated at **T3**. Mr Tillotson spoke to the resident tenants. They described being woken by a lightning storm, quickly

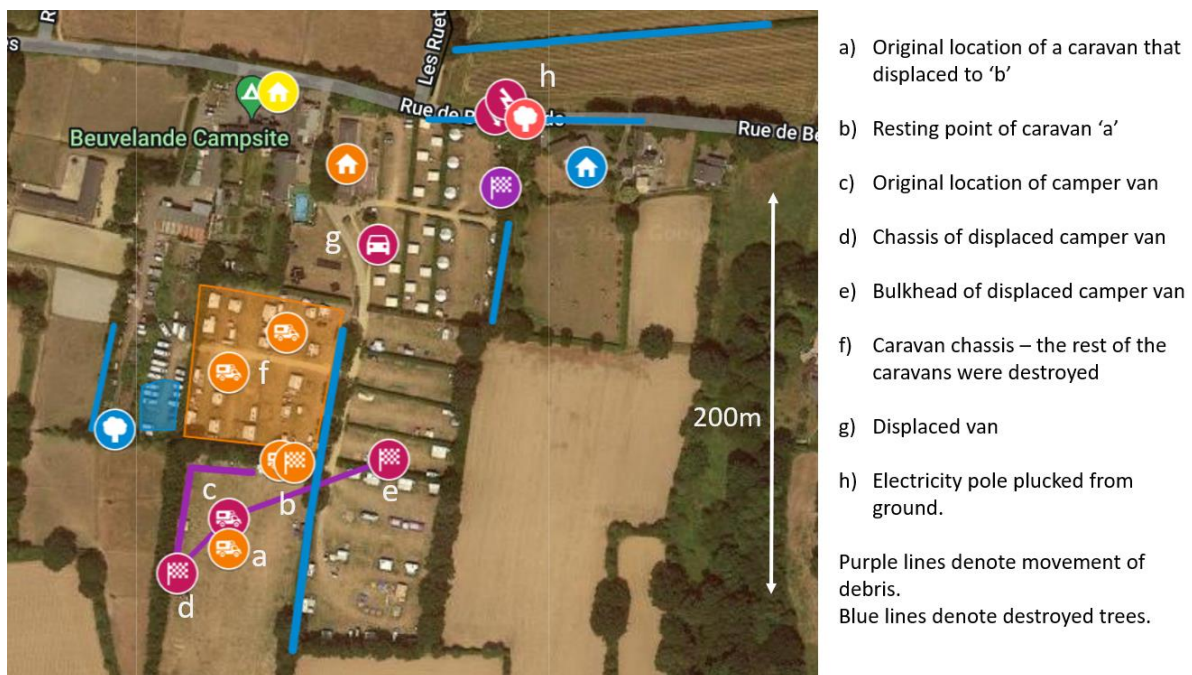
Figure 37: Map of Beuvelande campsite damage.

Many caravans were completely destroyed at the campsite. Pieces of them were wedged against hedges, particularly in the south-western field where they came to rest in the north-west corner. Caravan debris was also found scattered across the track in fields to the north-east of the campsite.

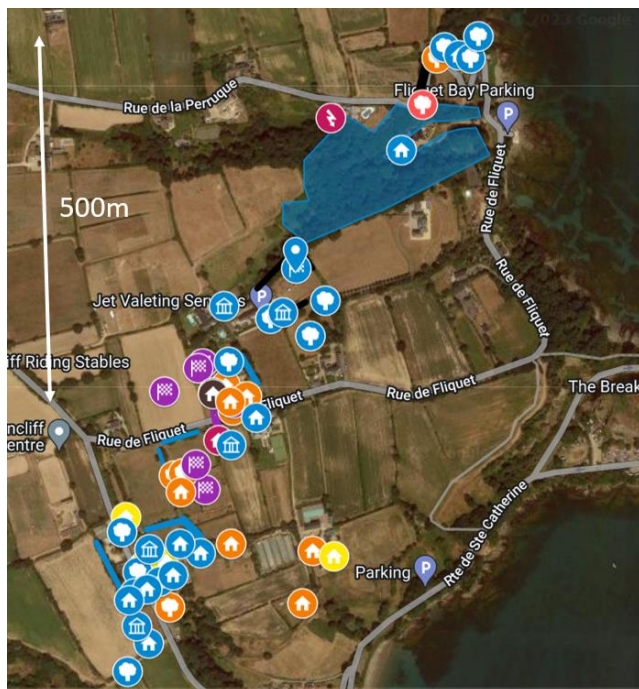
Figure 44: Map of Fliquet damage.

Homes to the north and east of the aforementioned houses were visited in person. There was roof damage consistent with a T3 tornado and as in many other places along the track, many windows were smashed. Trees generally fell towards the north-west.

The width of the tornado track was estimated here to be around 250m.

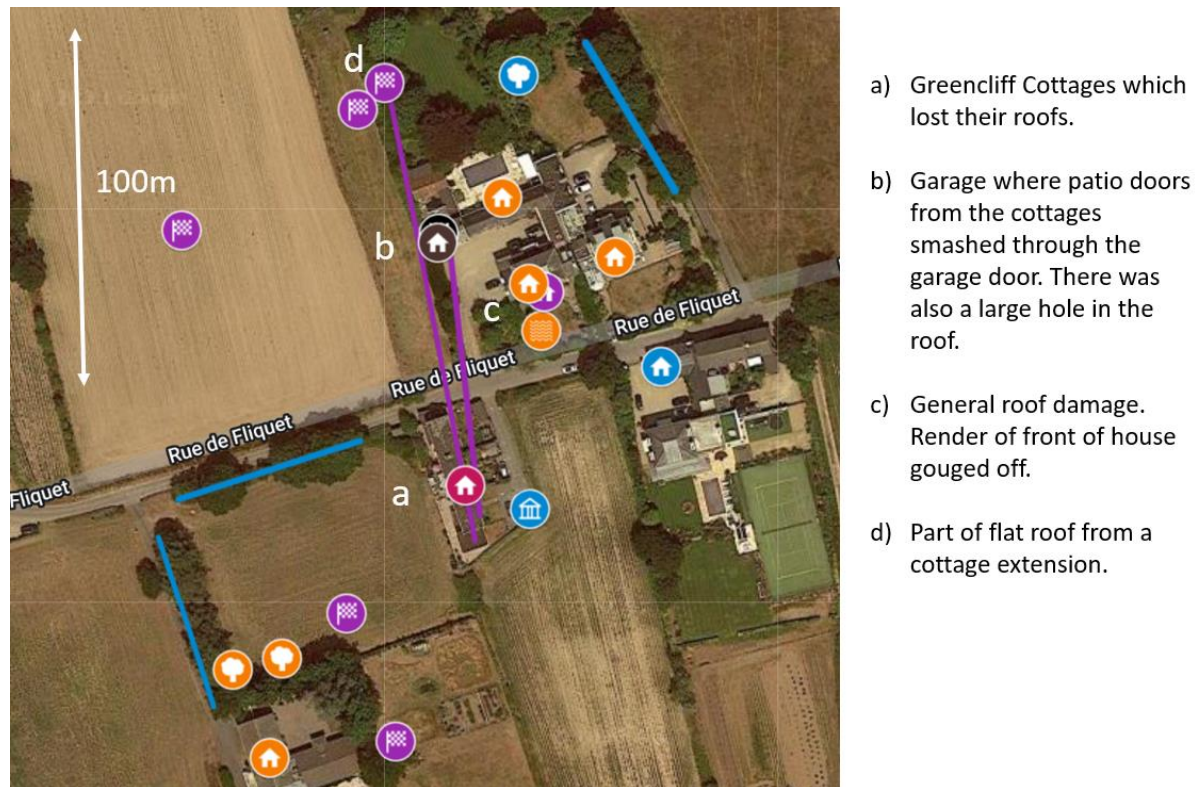
Figure 45: Detailed view of the most severe damage in Fliquet.

The in-person site investigation centred around where three terraced cottages, known as Greencliff Cottages, (49.2241N, -2.0294W; Figure 45 and Figure 46), had lost their roofs<sup>7</sup>. The cottages had been built in 1843 with apex roofs, with a flat roofed extension added to the southern-most property in 1978.

The tornado was rated at a maximum of **T6** here. This was due to the penetrating debris from the cottages hitting homes up to 60m away.

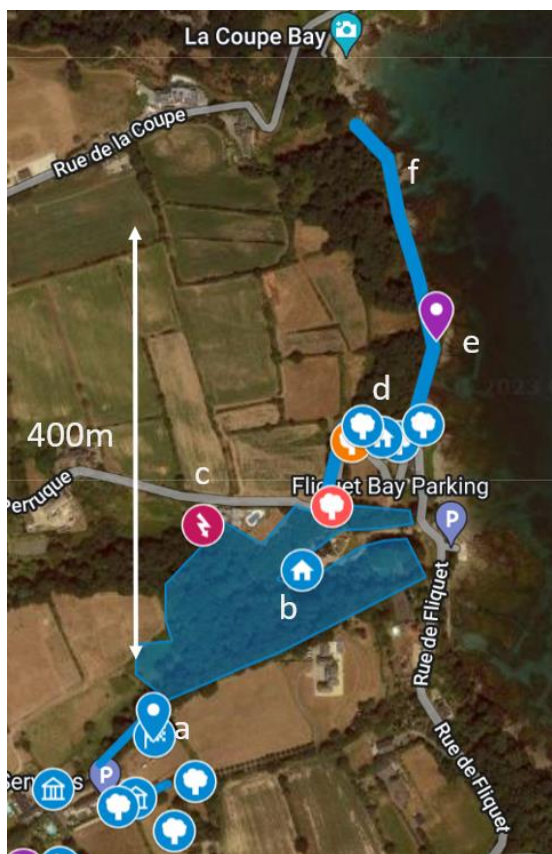
Figure 50: Map of where the tornado crossed the coast between Fliquet Bay and La Coupe Bay

- a) Trailer blown over
- b) General tree damage
- c) Fallen telegraph pole
- d) Roof damage to cottage
- e) Debris
- f) Tree damage

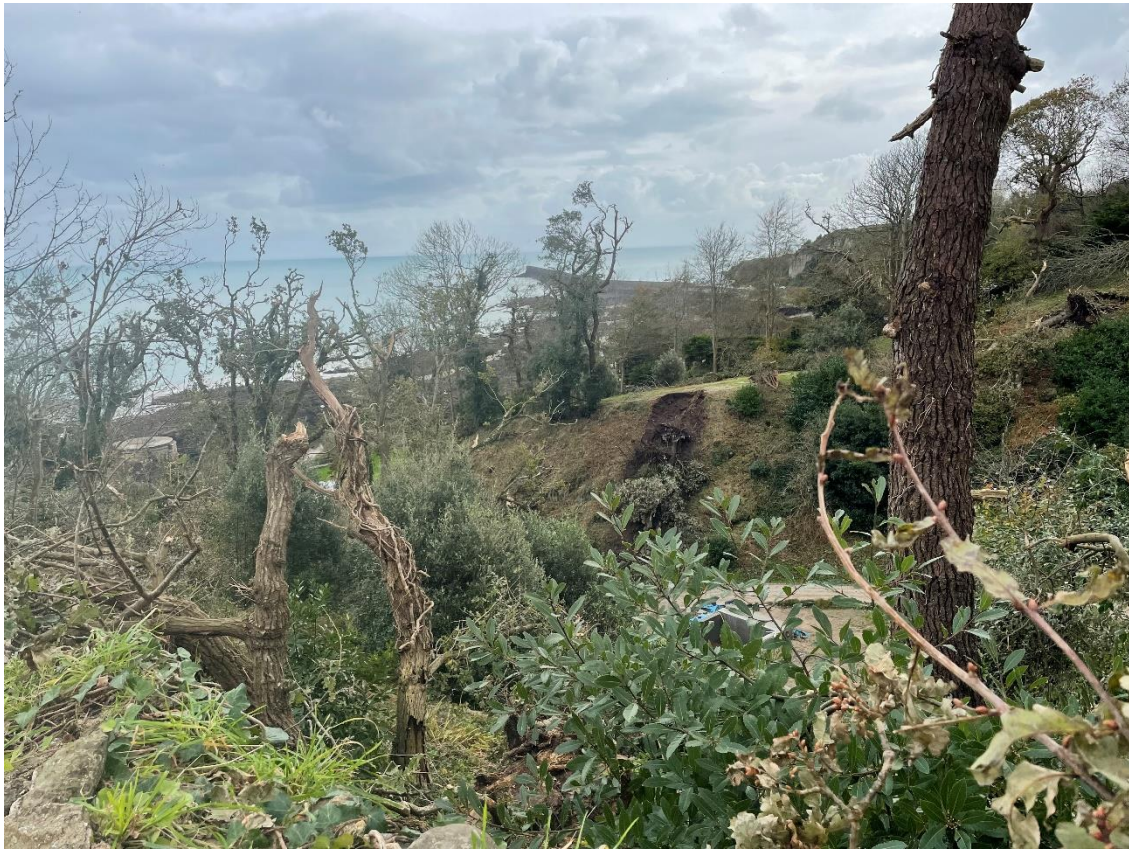
*Figure 51: Looking south-east across the valley above Fliquet from Rue De La Perruque.*

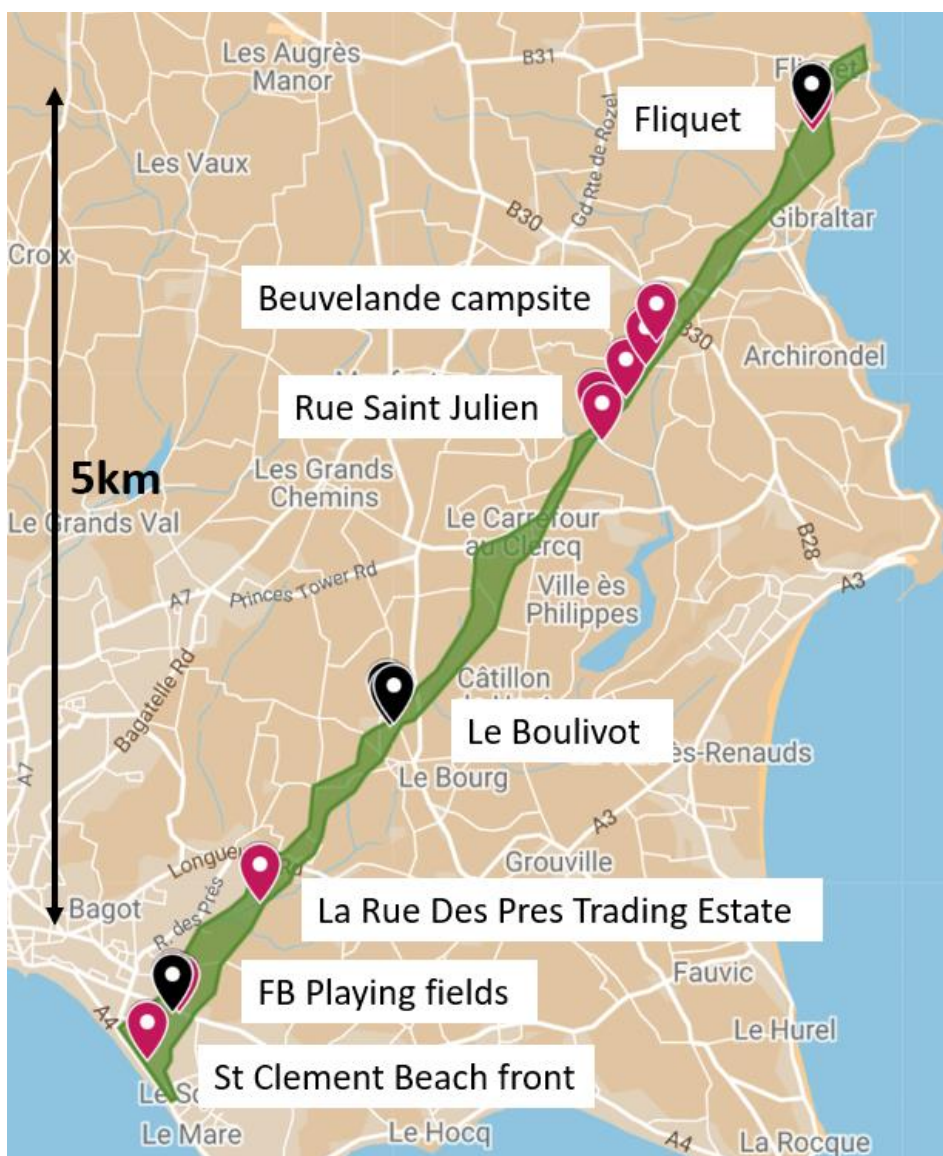
| Fliquet<br>(49.224N, -2.029W) | Total roof loss of three homes.<br>Penetrating debris. | T5<br><b>T6</b> |

Figure 52: Map of track with T5 (red) and T6 (black) locations marked.
